**EAST INTERLAKE CONSERVATION DISTRICT:
WATERSHED 050J RIPARIAN ASSESSMENT SURVEY – WITH
EMPHASIS ON THIRD ORDER DRAINS and HIGHER – 2007 and 2008**

P. G. Graveline

2008

North/South Consultants Inc.
Aquatic Environment Specialists

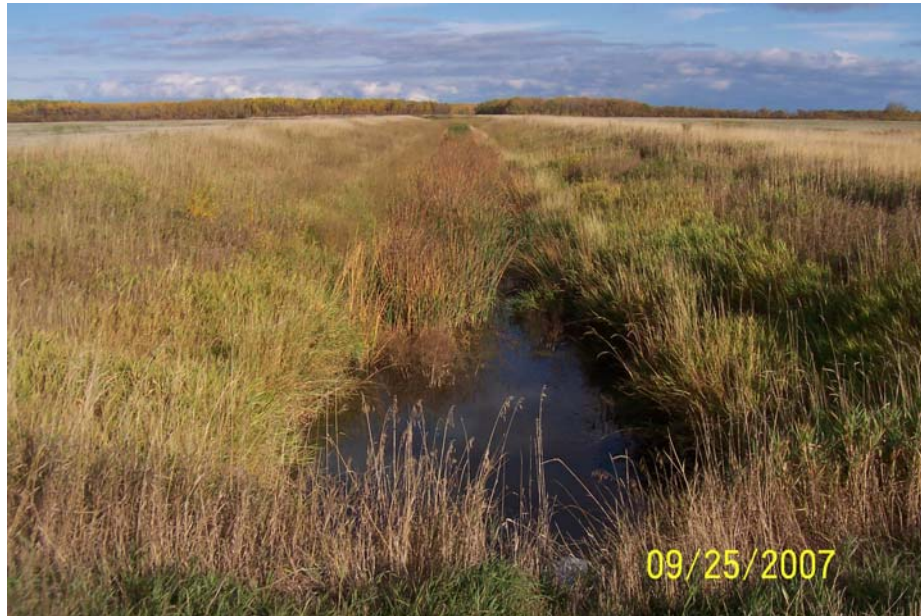
Photo 2. Looking downstream along Cochrane Creek, Wpt. 85, September 25, 2007.

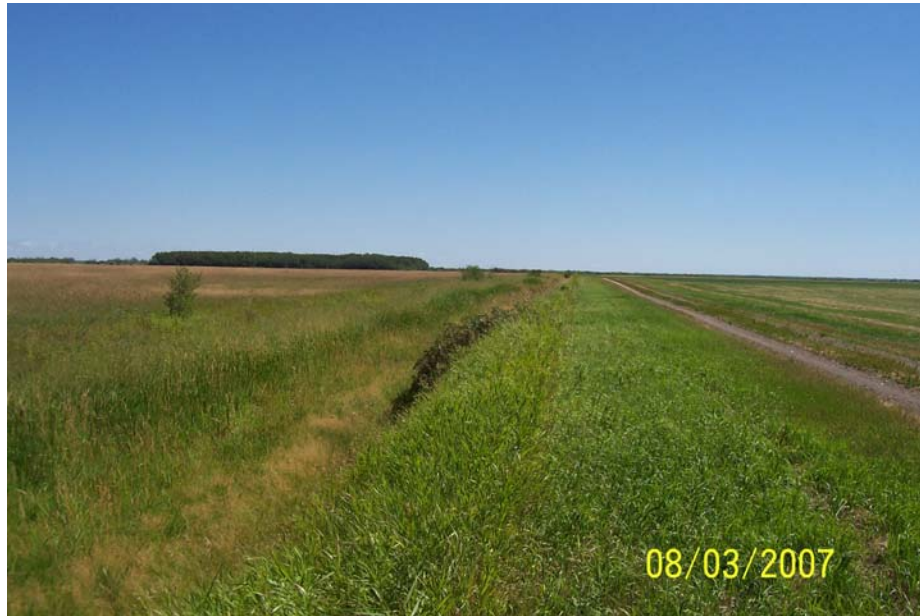
This highly channelized watercourse was given an aquatic habitat quality rating of Class C (highly impacted) (Table 6, Figure 9). The fish habitat observed (between waypoints 13 and 19) exhibited Class 4 fish habitat (i.e., severe limitations to production of fish) and should be considered as marginal (Figure 6).

Photo 3. Looking downstream on Fisher Drain at Wpt. 17, August 3, 2007.

One potential rehabilitation site was identified on the Fisher Drain (Table 7, Figure 9). Involving bank erosion, this site (#30) was given a priority 3 due to the close proximity of the agricultural practice (i.e., crops).

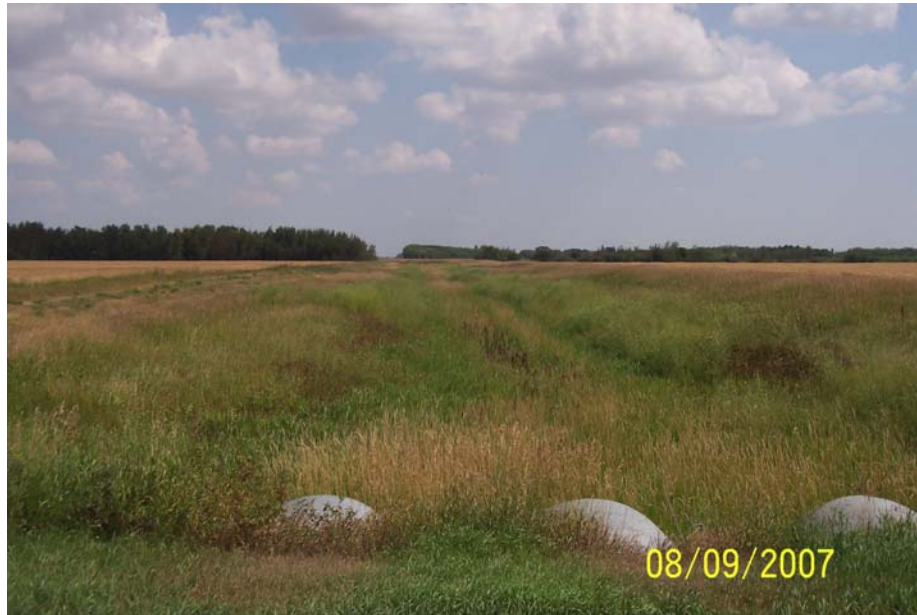
All (100%) of the 8.8 km of the Gramiak Drain reviewed for land use/cover was determined to be other agricultural land (Table 5). The Gramiak Drain is primarily a ‘grassed ditch’, channelized (likely) to accelerate the flow of water from agricultural land, and was therefore rated as Class C (highly impacted) (Table 6, Figure 11). In addition, the fish habitat along this drain is considered as Class 4 (severe limitations to fish production) and/or comprising marginal habitat.

Photo 4. Looking downstream along Gramiak Drain, Wpt. 35, August 8, 2007.

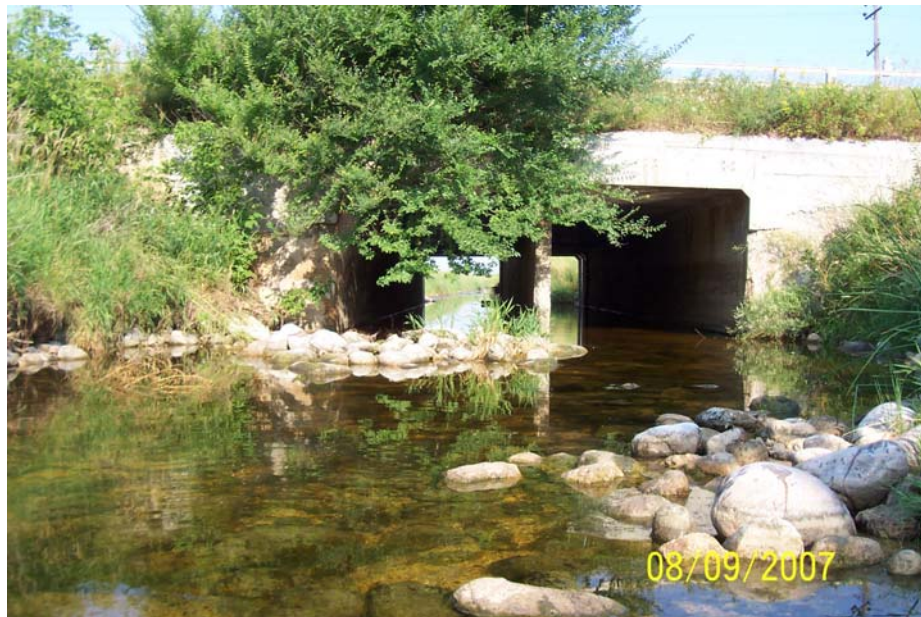
Water quality parameters measured in the field (by North/South Consultants Inc.) are provided in Appendix 2 (Table A2-2). Dissolved oxygen measured at waypoint 26 on August 26, 2007 was below the MWQ objective instantaneous minimum of 5.00 mg/L for the protection of cool water aquatic life (i.e., 3.94 mg/L) (Photo 5). However, when measured at Wpt. 26 on October 25 the dissolved oxygen was within the MWQ guidelines (i.e., 11.29 mg/L).

Photo 5. Grassmere Creek Drain at Wpt. 26, August 9, 2007.

johnny darter; and pearl dace. A number of forage fish (likely pearl dace) were also observed at Wpt. 26 (Photo 5).

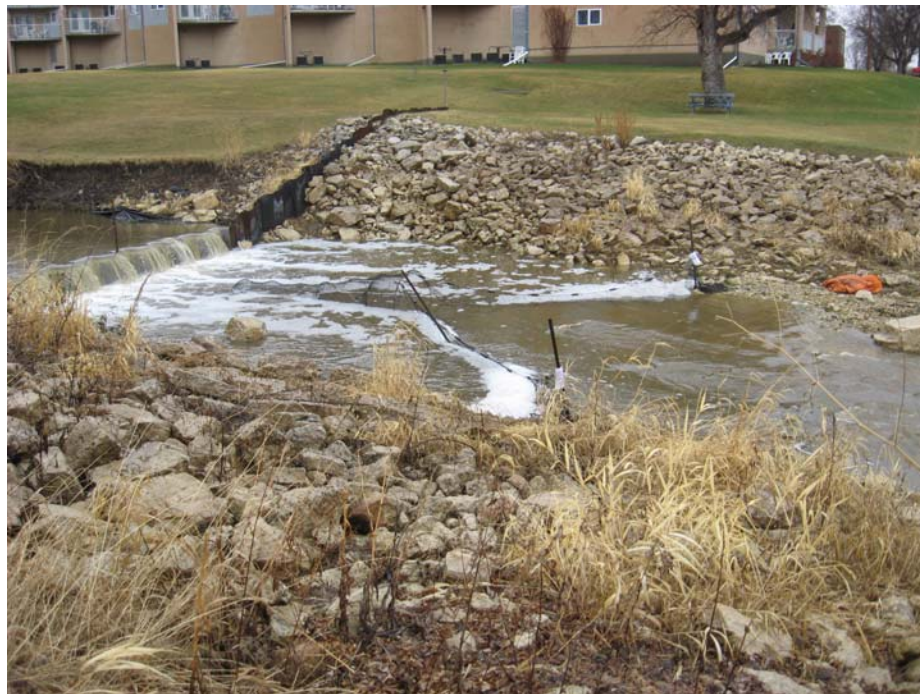
The hoopnet set at Wpt. 90 (located on the downstream side of a sheet pile weir) captured 23 northern pike in less than 24 hours (Photo 6). The majority of these fish were ripe males and/or females ready to spawn in the current year. Under the flow conditions exhibited in the spring of 2008 (i.e., 0.296 m³/sec on April 23 determined by North/South Consultants) the sheet pile weir located at the mouth of this drain effectively prevented the upstream

Photo 6. Hoop net near the mouth of Grassmere Creek Drain (Wpt. 90), spring 2008.

migration of fish species. In previous years of higher water (i.e., discharges greater than 0.296 m³/sec) local residents have seen migrations of what appeared to be northern pike and sucker species migrating past their properties (located between Hwys. 8 and 9). This

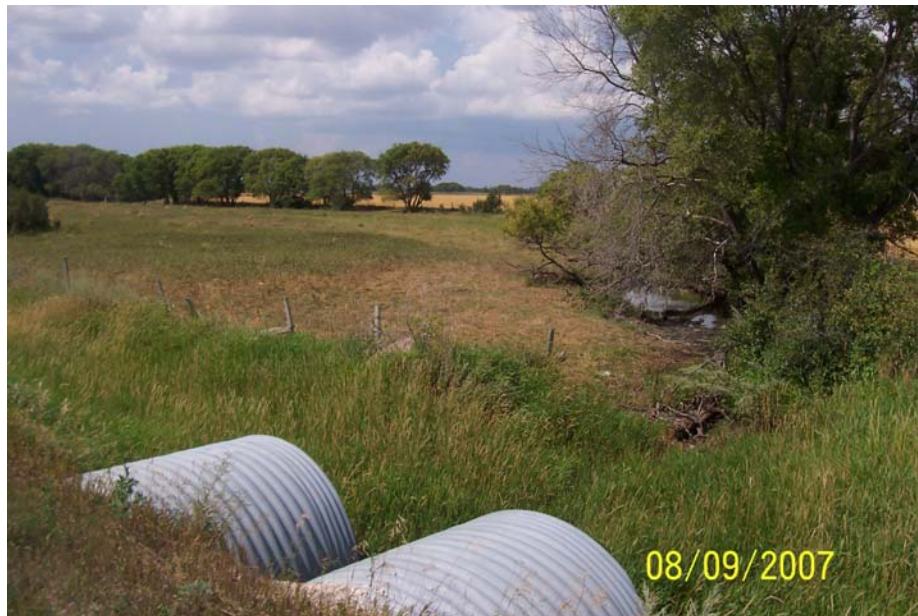
No discharge measurements or fisheries investigations were conducted on Jackfish Creek in 2007 due to minimal/non-existent water levels (Photo 7). Jackfish Creek was also not identified for spring fisheries investigations in 2008 .

Photo 7. Looking upstream on Jackfish Creek at Wpt. 38, August 9, 2007.

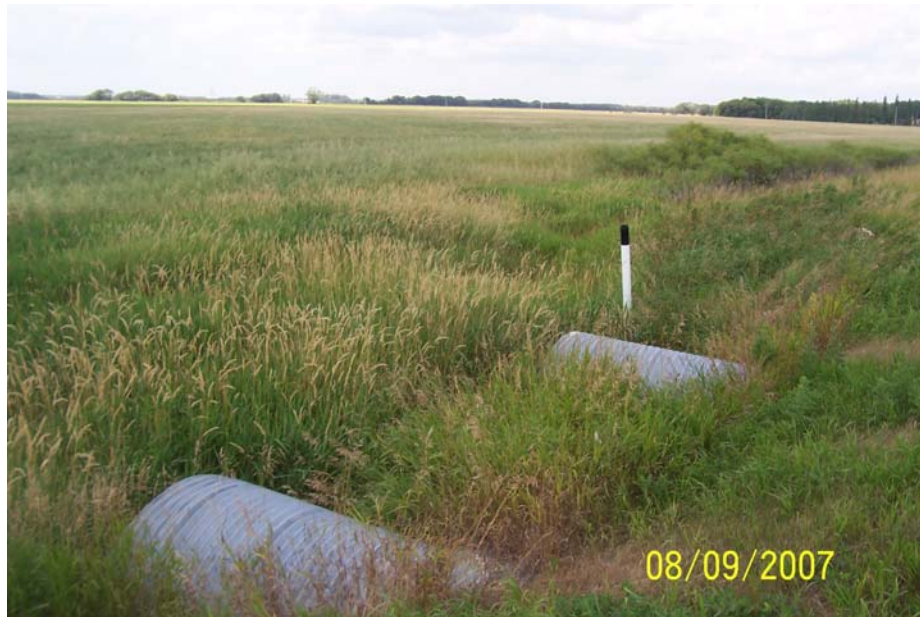
Photo 8. Looking upstream on Jennifer Creek at Wpt. 36, August 9, 2007.

Along Jennifer creek, other agricultural land (59.6%) (i.e., cropland and hayland) was the primary land use/cover, followed by pasture/grazing (38.2%), and mixed forest (2.2%) (Table 5, Figure 7). The two reaches of pasture/grazing identified along this creek appear to be extensive and may warrant additional investigation.

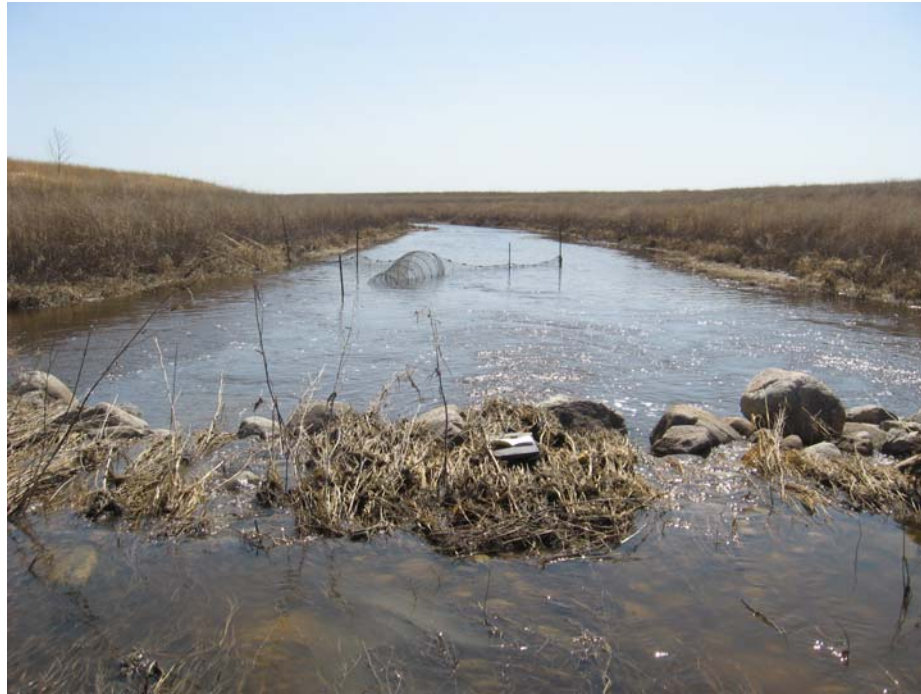
One hoop net was set on Netley Creek in the spring, 2008, west of Hwy. 8 (Wpt. 89; Figure 6, Appendix Table A1-1) (Photo 9). Effectively fishing for three days, 3 species of fish were captured at this site, including: 27 white sucker; two northern pike; and one walleye (Table 4). One northern pike was a female ready to spawn in the current season and the other was a male, preparing to spawn. The walleye was also a male preparing to spawn in the current season. The majority of the white suckers captured were males, either ready to

spawn ($n = 12$) or preparing to spawn ($n = 7$) in the current season. Eight female white suckers were captured

Photo 9. Hoop net set on Netley Creek (at Wpt. 89) to capture fish moving upstream, spring 2008.

also preparing to spawn in the current season. The data suggests that, at least with the sucker species, sexually mature (adult) fish can migrate approximately 25 km upstream on the Netley Creek. With suitable flow conditions, these fish would likely continue their migration to the next impassable barrier. This may be as far as the control structure located at the end of Netley Creek and the Norris lake control structure. At this location there have been reports of white sucker and northern pike in the spring. However, on April 21 there was no flow into Netley Creek from the outlet and, subsequently, no fish present at Wpt. 41 (Figure 6).

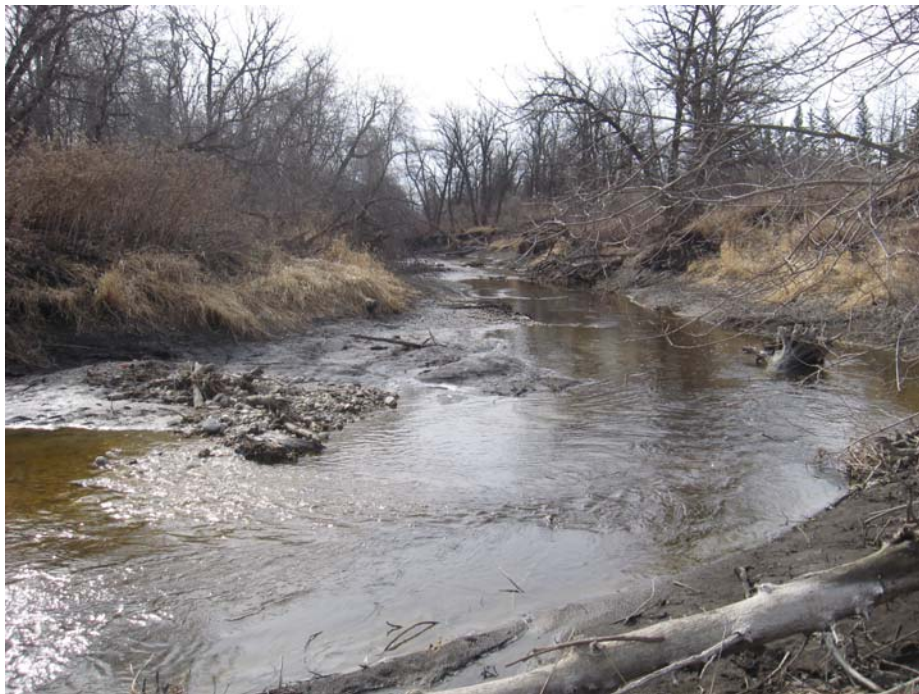
No hydrometric data was found on the Water Survey of Canada website (ECWSC 2008) and WQMS-MWS (2007) did not have existing information pertaining to Parks Creek. The elevation change along Parks Creek is gradual, dropping only 7 meters over a course of approximately 13 km (Table 1, Figures 1 and 4). The majority of this change (i.e., 6 m) occurs between Hwy. 9 and the confluence with the Red River (Photo 10).

Photo 10. Parks Creek, between the mouth and Hwy. 9, spring 2008.

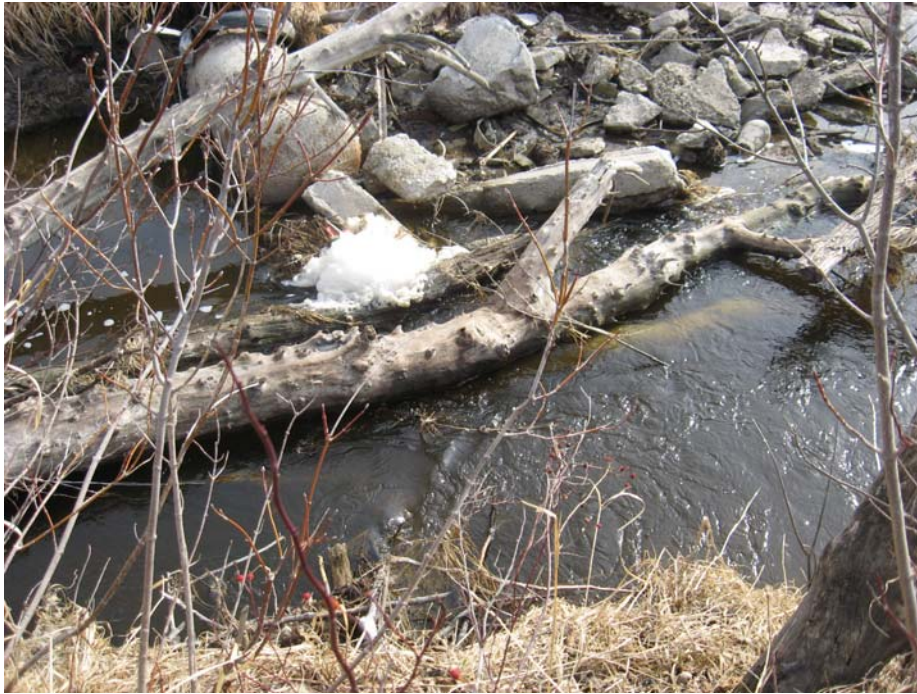
Aquatic habitat quality along Parks Creek was determined to be primarily Class C habitat (89.0%), followed by: Class B (6.3%) and Class D (4.7%) habitat. From its confluence with the Red River, upstream (just past Wpt. 88), Parks Creek may fall within a Class 3 rating (moderate limitations to production of fish) but be important habitat (Figure 8). However,

Photo 11. Debris on Parks Creek, between Hwy. 9 and the Red River, spring 2008.

upstream of Wpt. 88 the fish habitat within Parks Creek has more severe limitations to the production of fish (i.e., Class 4) comprising ‘marginal habitat’.

One potential rehabilitation site (#42) was identified on Parks Creek (Table 7, Figure 11). Located at Hwy. 9 (Wpt. 29), this Priority 3 site exhibited eroding banks likely exacerbated by the presence of a drainage culvert located at the top of the right bank and a formerly cultivated field with denuded riparian. The infrastructure at this site (i.e., bridge) is also failing, depositing large chunks of concrete into the main channel of the creek. It is assumed that the structure and creek banks at this site will be rehabilitated in the near future based on the Manitoba Infrastructure and Transportation proposed fall advertising schedule for the 2008 construction season (www.gov.mb.ca/mit/contracts/capitalprogram/schedule.pdf, Accessed February 2008).

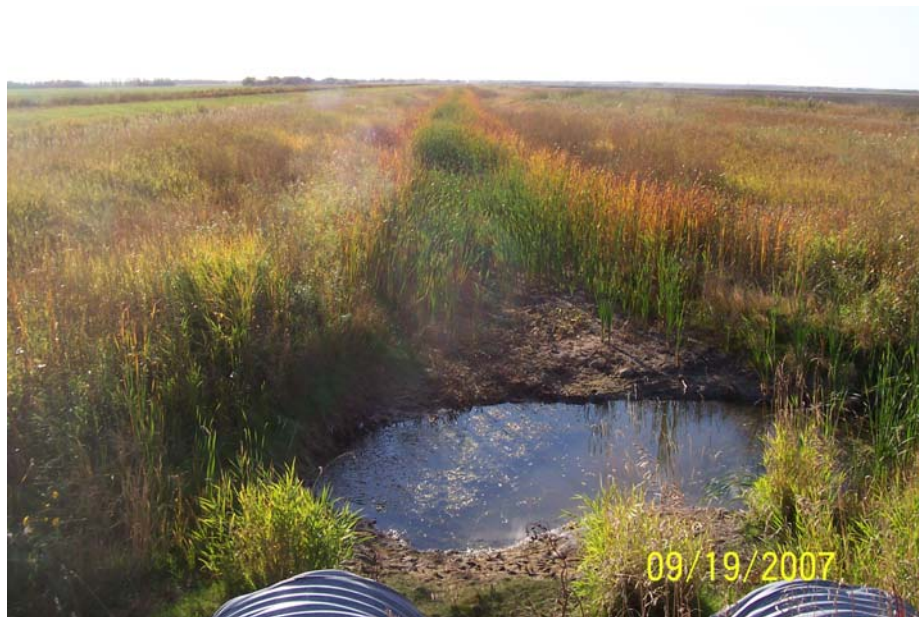
No stream properties (i.e., discharges, depths, substrate composition) or summer/fall fish utilization surveys were conducted on Ross Creek in 2007 due to non-existent and/or marginal stream flows (Photo 12).

Photo 12. Looking upstream along Ross Creek (Wpt. 79), September 19, 2007.

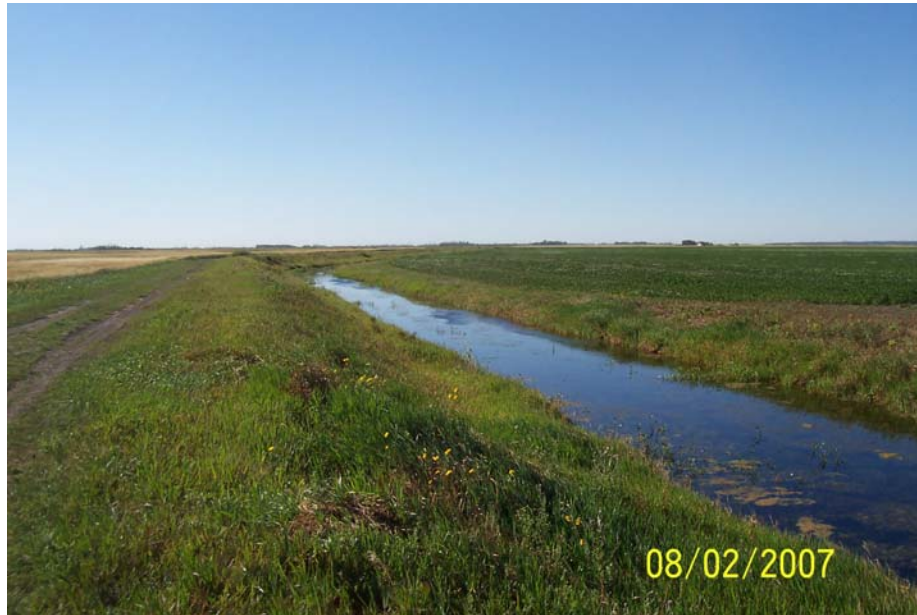
Wpt. 5, but wetted between Wpts. 3 and 4. The water between these waypoints appeared to maintain a constant depth (due to channelization) and did not exhibit any flow (Photo 13).

Photo 13. Looking upstream along Steele Drain (Wpt. 4), August 2, 2007.

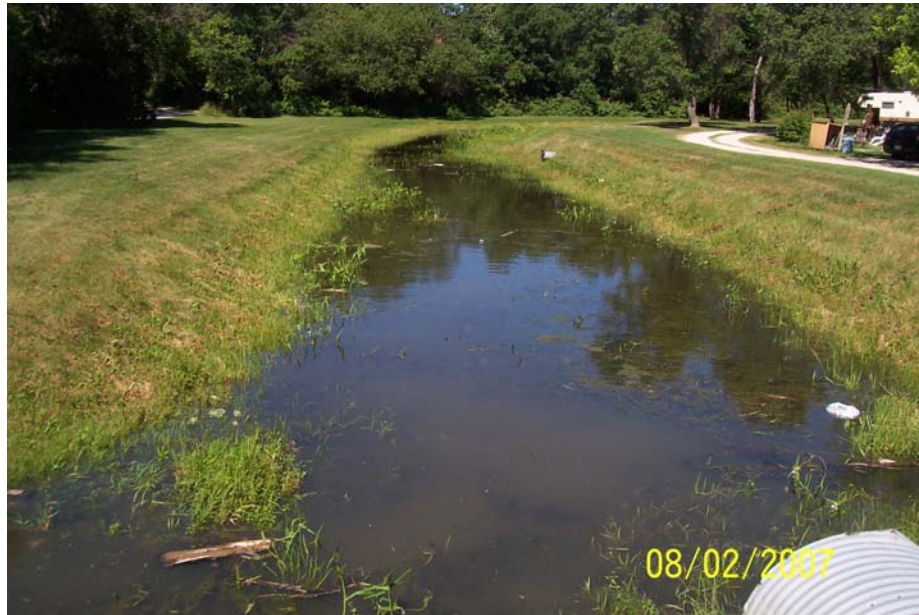
The 2.3 km of Tugela Creek reviewed for land use/cover was primarily hayland (80.0%) and, to a lesser extent, residential/commercial (20.0%) (Table 5, Figure 6) (Photo 14).

The length of Tugela Creek reviewed for aquatic habitat quality received a Class C (i.e., highly impacted with altered hydraulic regimes) (Table 6, Figure 9). This watercourse is primarily channelized, flows through a residential area, is surrounded by hayfields, and maintains minimal flow; it should therefore be designated as having Class 4 fish habitat (severe limitations to production of fish) and/or comprising marginal fish habitat. However

Photo 14. Looking upstream along Tugela Creek (Wpt. 19), August 2, 2008.

it is a direct tributary to Lake Winnipeg and, under certain hydraulic conditions, its mouth could provide some degree of fisheries habitat (e.g., spawning, rearing, feeding).

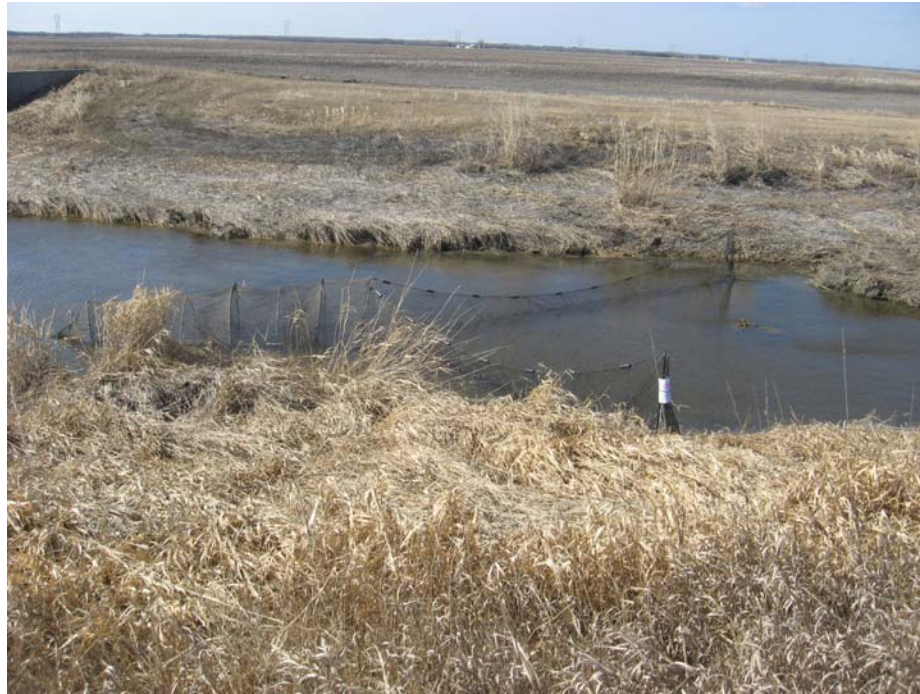
The aquatic habitat quality along Wavey Creek was determined to be primarily Class C (69.4%), followed by Class A (27.1%) and Class B (3.5%) habitat (Table 6, Figure 10). The relatively high percentage of Class A habitat may be attributable to the remaining natural riparian areas and lack of channelization of this watercourse from its confluence with Netley Creek upstream to Wpt. 22 (Figure 7). With it's natural sinuosity, varying depths and substrates, healthy riparian, etc. this section of Wavey Creek (i.e., confluence to Wpt. 22) can be defined as having Class 1 fish habitat (i.e., high capability for fish production) and/or

Photo 15. Hoop net set on Wavey Creek, just downstream of the control structure at Wpt. 78, spring 2008.

comprising important habitat. Upstream from Wpt. 22 to Wpt. 5, Wavey Creek is primarily channelized having comparable depths, substrate, and (often) minimal riparian. This section of watercourse was therefore identified as having Class 4 fish habitat (i.e., severe limitations to production of fish) and/or marginal fish habitat.

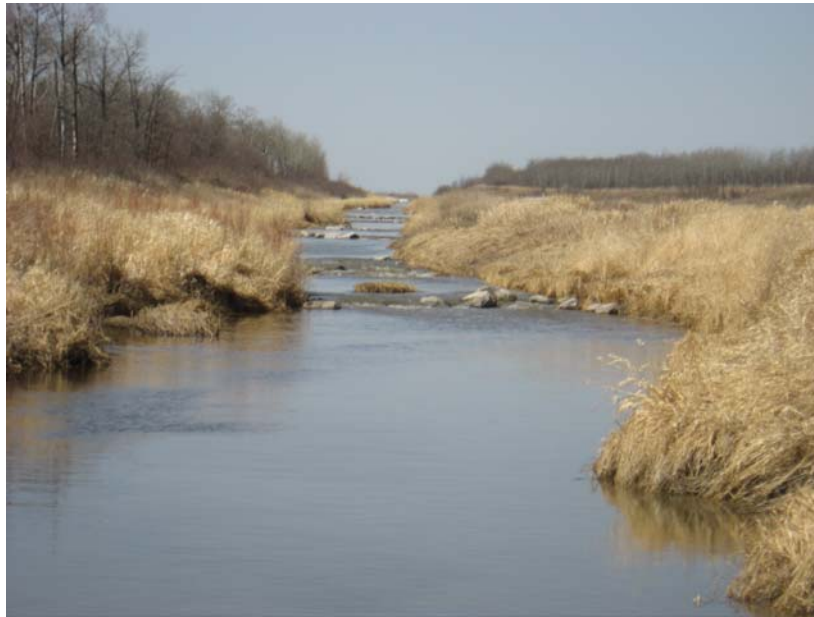
Five potential rehabilitation sites were identified on Wavey Creek with an additional site identified on a wider tributary entering Wavey Creek (Table 7, Figure 10). Rehabilitation Site 1, located on the extension of Wavey Creek, was designated a Priority 1. Given the extent of grazing/livestock access and proximity to Lake Winnipeg, the possibility of nutrient loading to this waterbody should be addressed. Rehabilitation sites 2 and 3 (both Priority 2) revealed the likelihood of extensive grazing. Rehabilitation sites 4, 5, and 6 (all Priority 3) identified areas of: potential rock barrier; grazing areas; and a barrier at a cement ford; respectively. Although no information was available regarding Site 4, it is possible that this area is the site of previous rehabilitation efforts (e.g., placement of aggregate as

Photo 16. Looking upstream on Wavey Creek (Wpt. 22) towards riffle sequence, spring 2008.

spawning habitat in a riffle sequence or to slow velocities) (Photo 16). Groundtruthing investigations could be warranted at this site during spring migrations. Identified as a low level, concrete and culvert ford, in 2007 Site 6 was unlikely a barrier to upstream fish migration. However, this site should be monitored periodically for accumulations of debris (which could hinder upstream and downstream movements) or washouts (which could cause bank erosion and subsequent sediment loading).

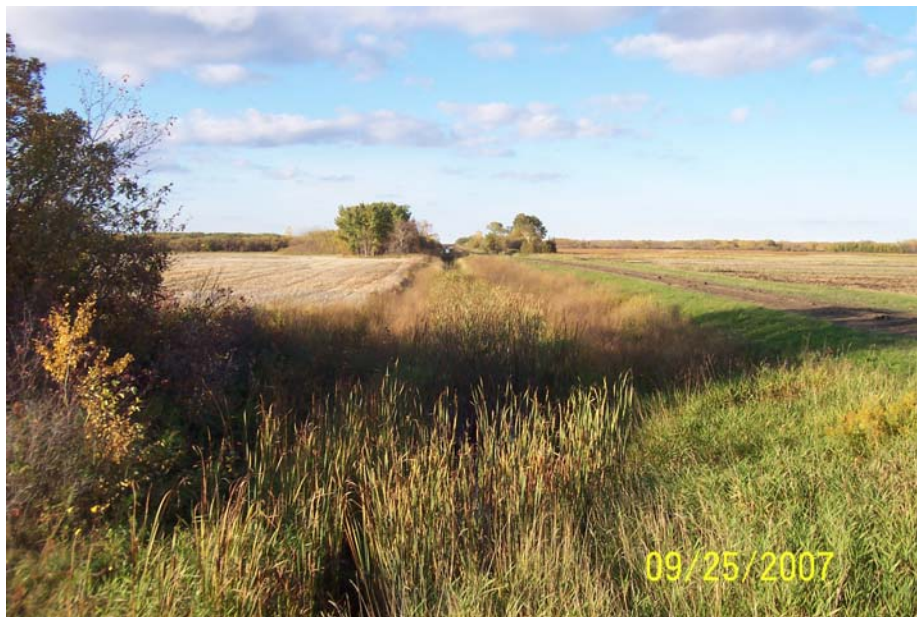
With the exception of ground based photography and aerial reconnaissance, no field inspections (i.e., hydrometric surveys or fisheries investigations) were conducted on Whiskey Ditch in 2007. The area of this ditch that was accessible by road exhibited minimal to non-existent flow conditions (i.e., dry) (Photo 17).

Photo 17. Looking downstream along Whiskey Ditch (Wpt. 86), September 25, 2007.

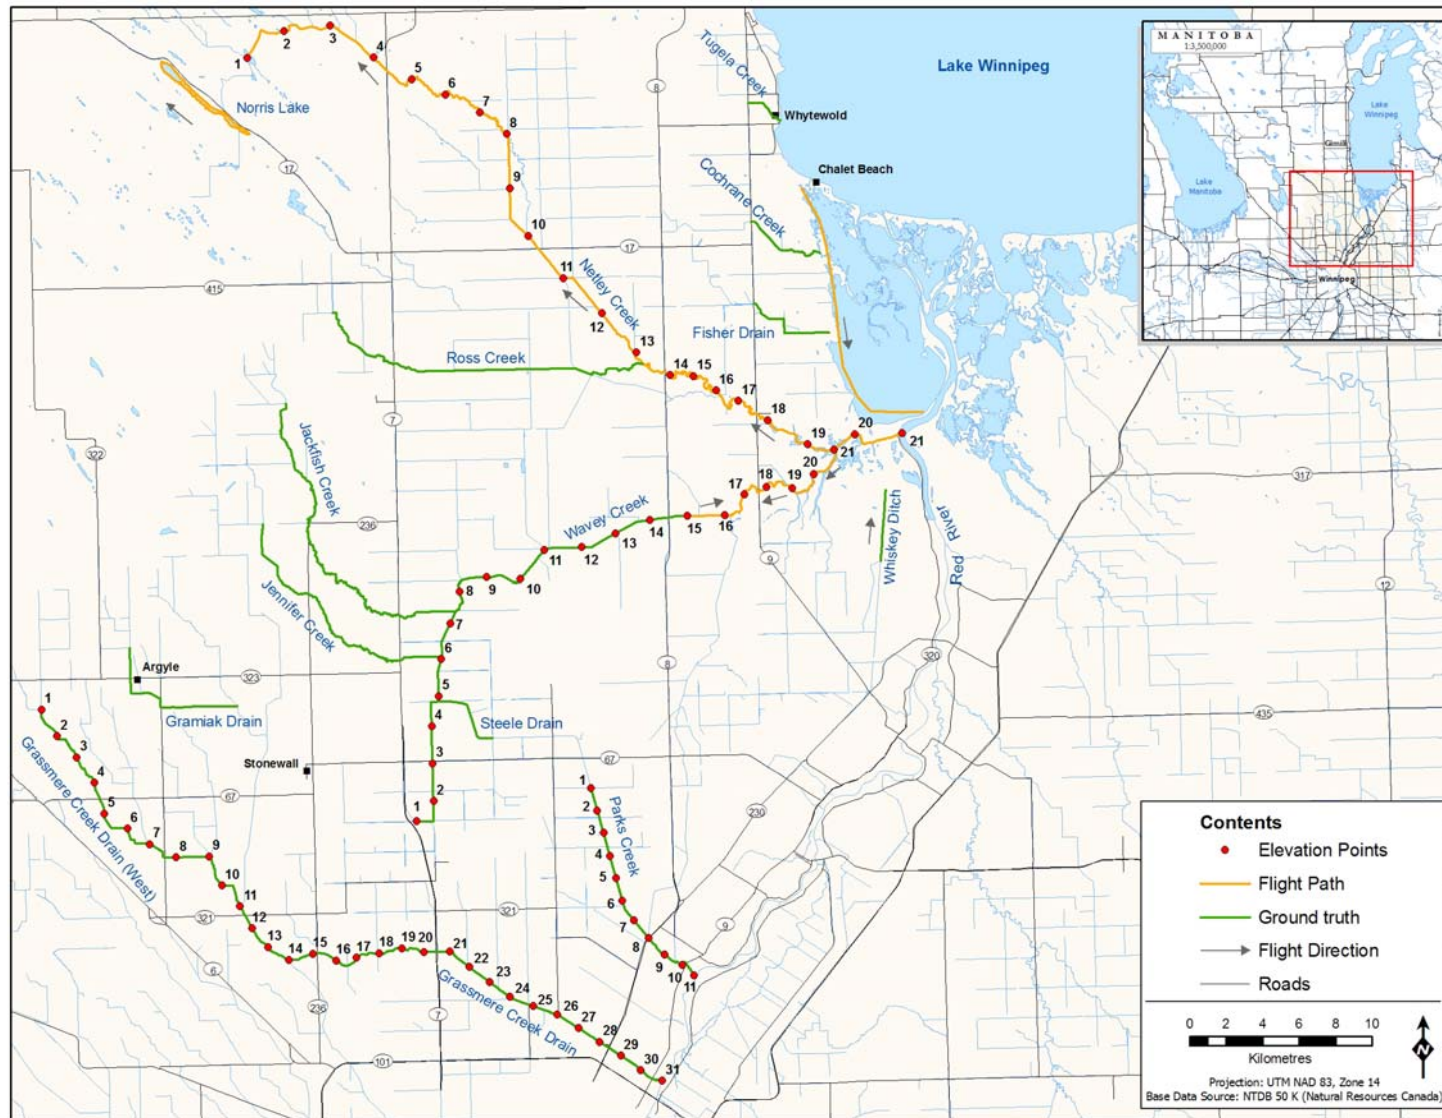
Figure 1. Watershed 050J study area, reaches of watercourse viewed by ground and air, and elevation points used to generate selected elevations profiles.

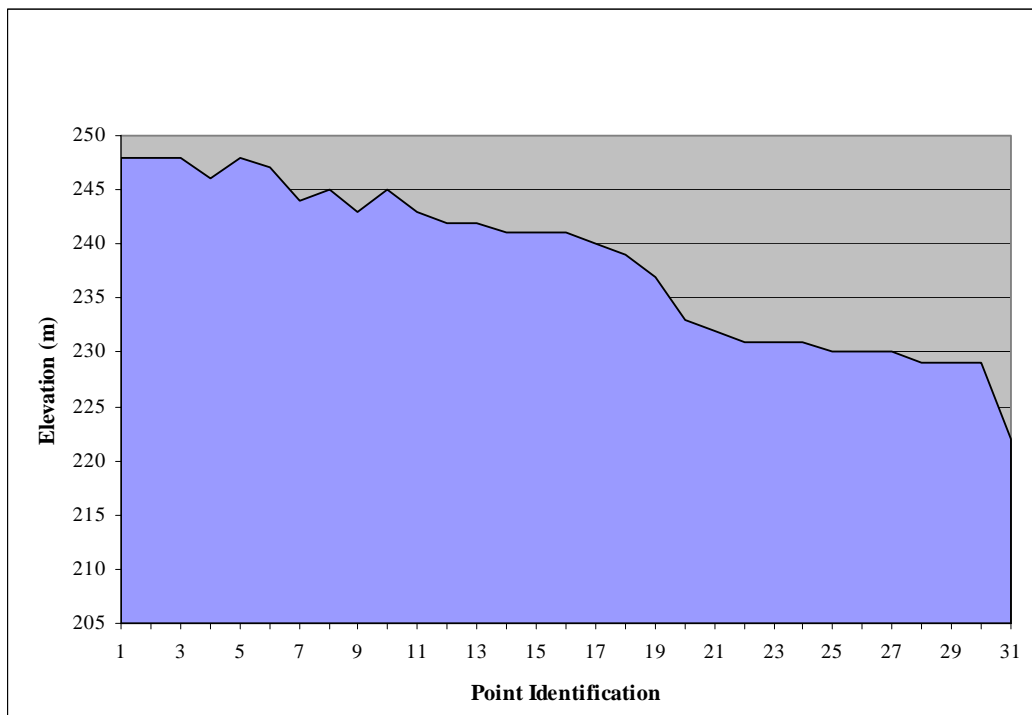
Figure 2. Longitudinal elevation profile (m) along the Grassmere Creek Drain.

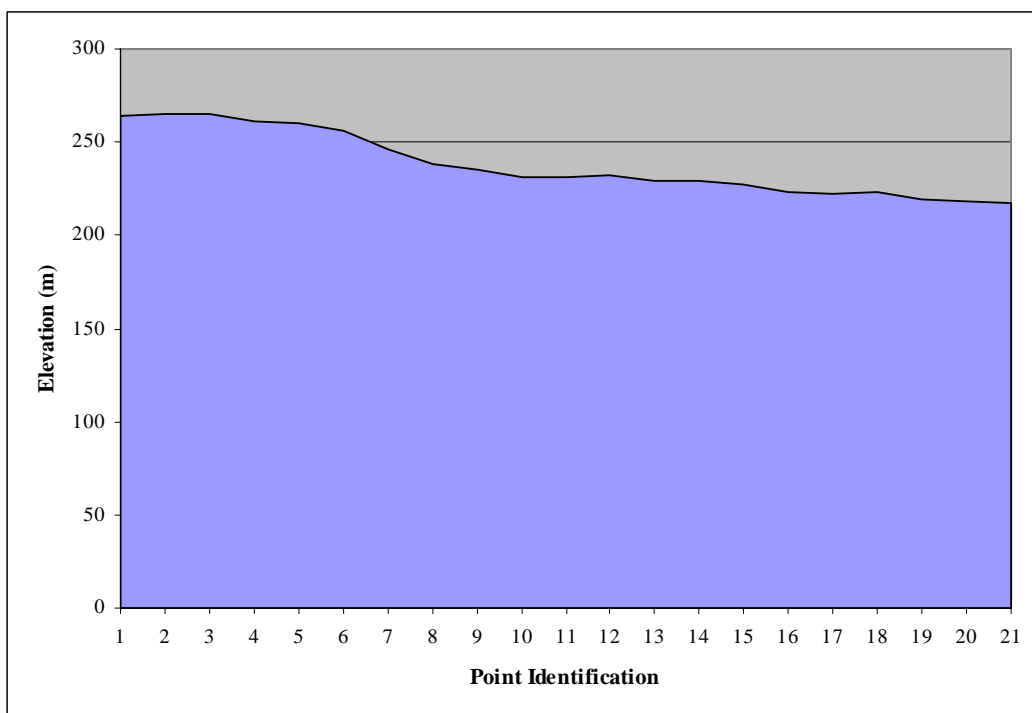
Figure 3. Longitudinal elevation profile (m) along Netley Creek.

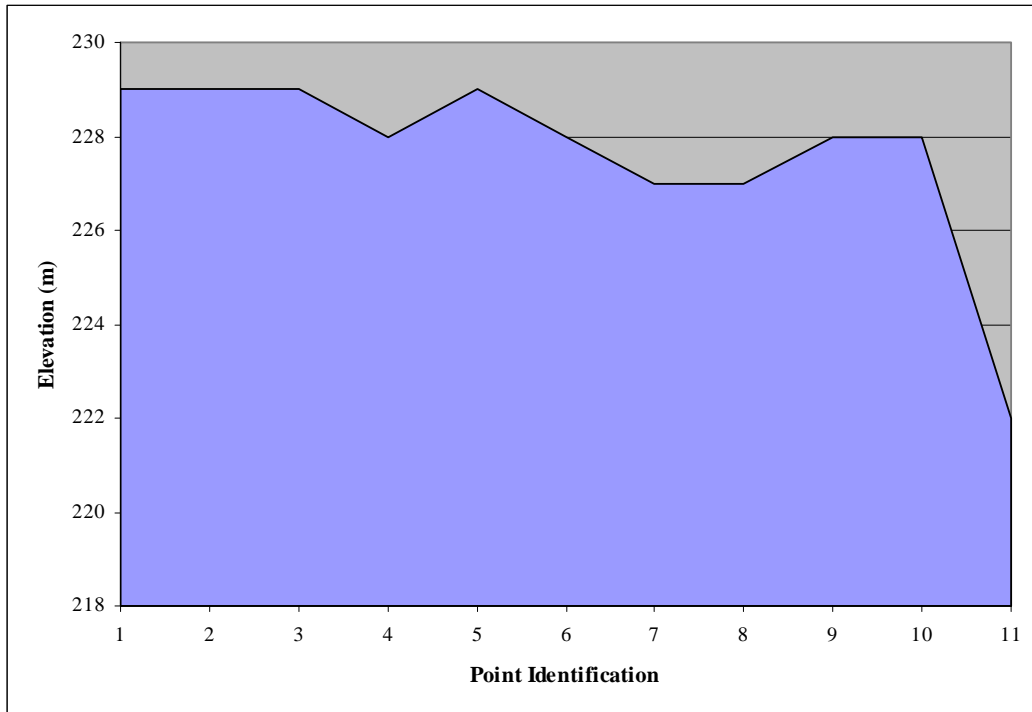
Figure 4. Longitudinal elevation profile (m) along Parks Creek.

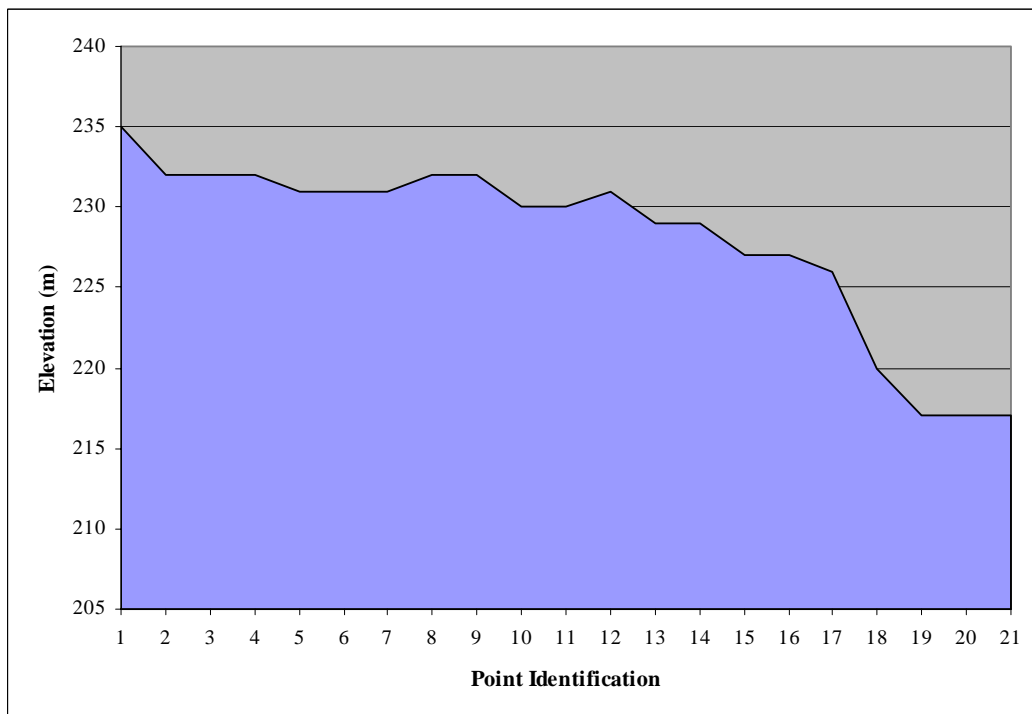
Figure 5. Longitudinal elevation profile (m) along Wavey Creek.

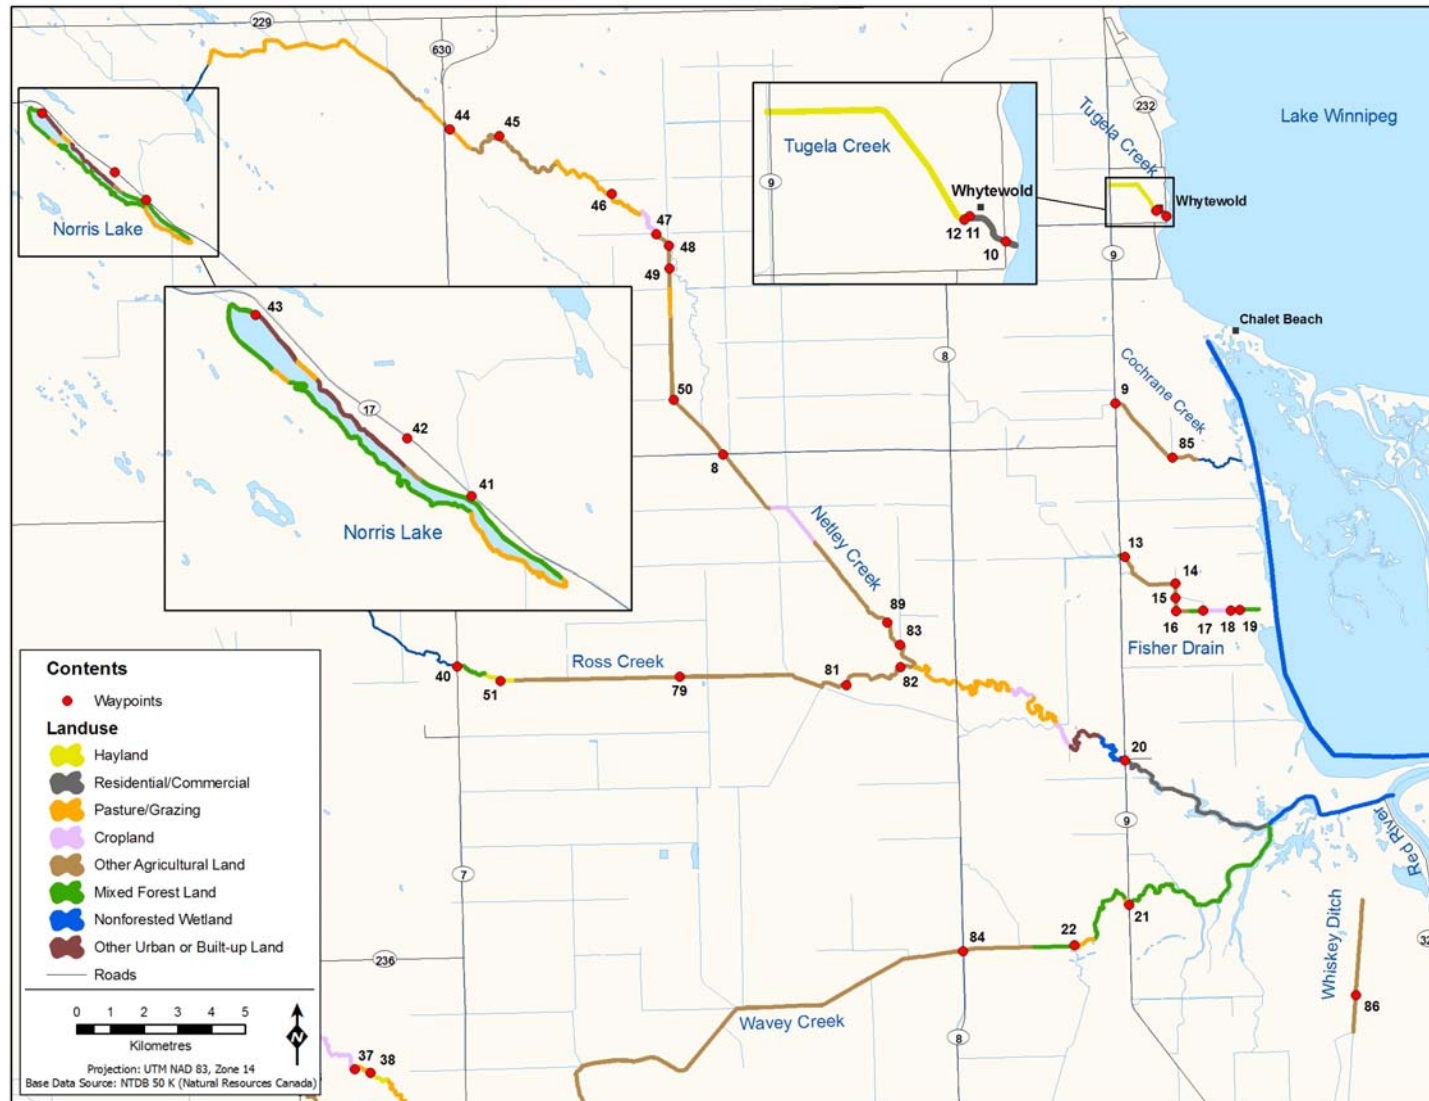
Figure 6. Sites groundtruthed throughout the northern portion of Watershed 050J, indicated by waypoint #, and specific land use/cover identified, 2007.

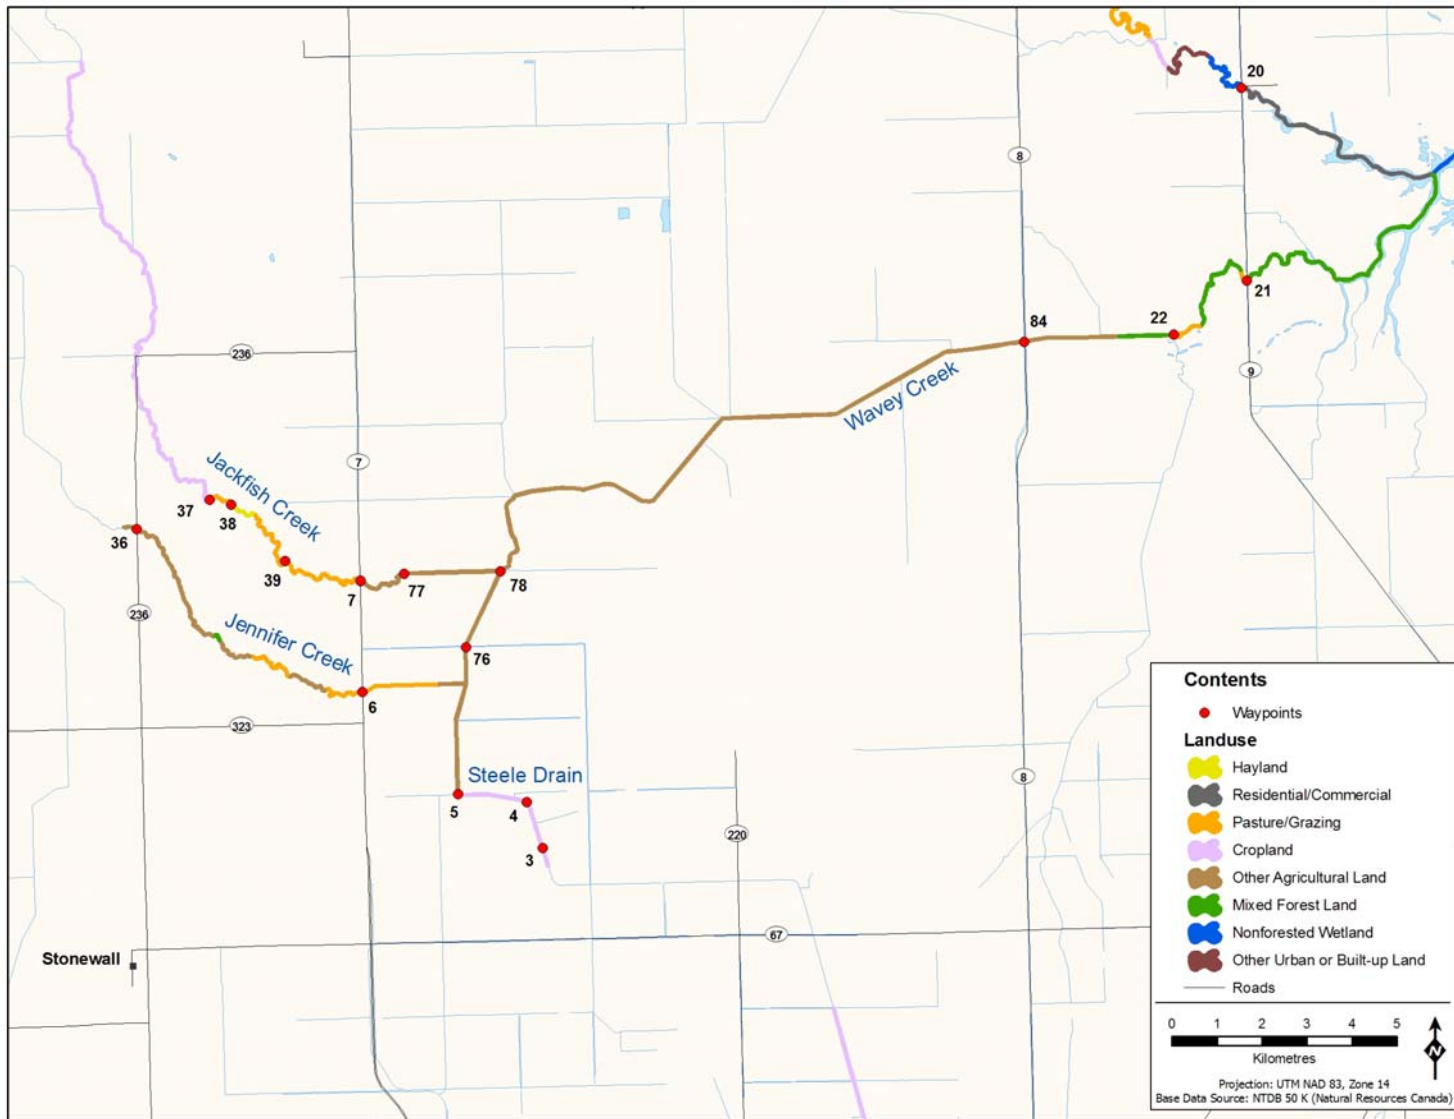
Figure 7. Sites groundtruthed throughout the central portion of Watershed 05OJ, indicated by waypoint #, and specific land use/cover identified, 2007.

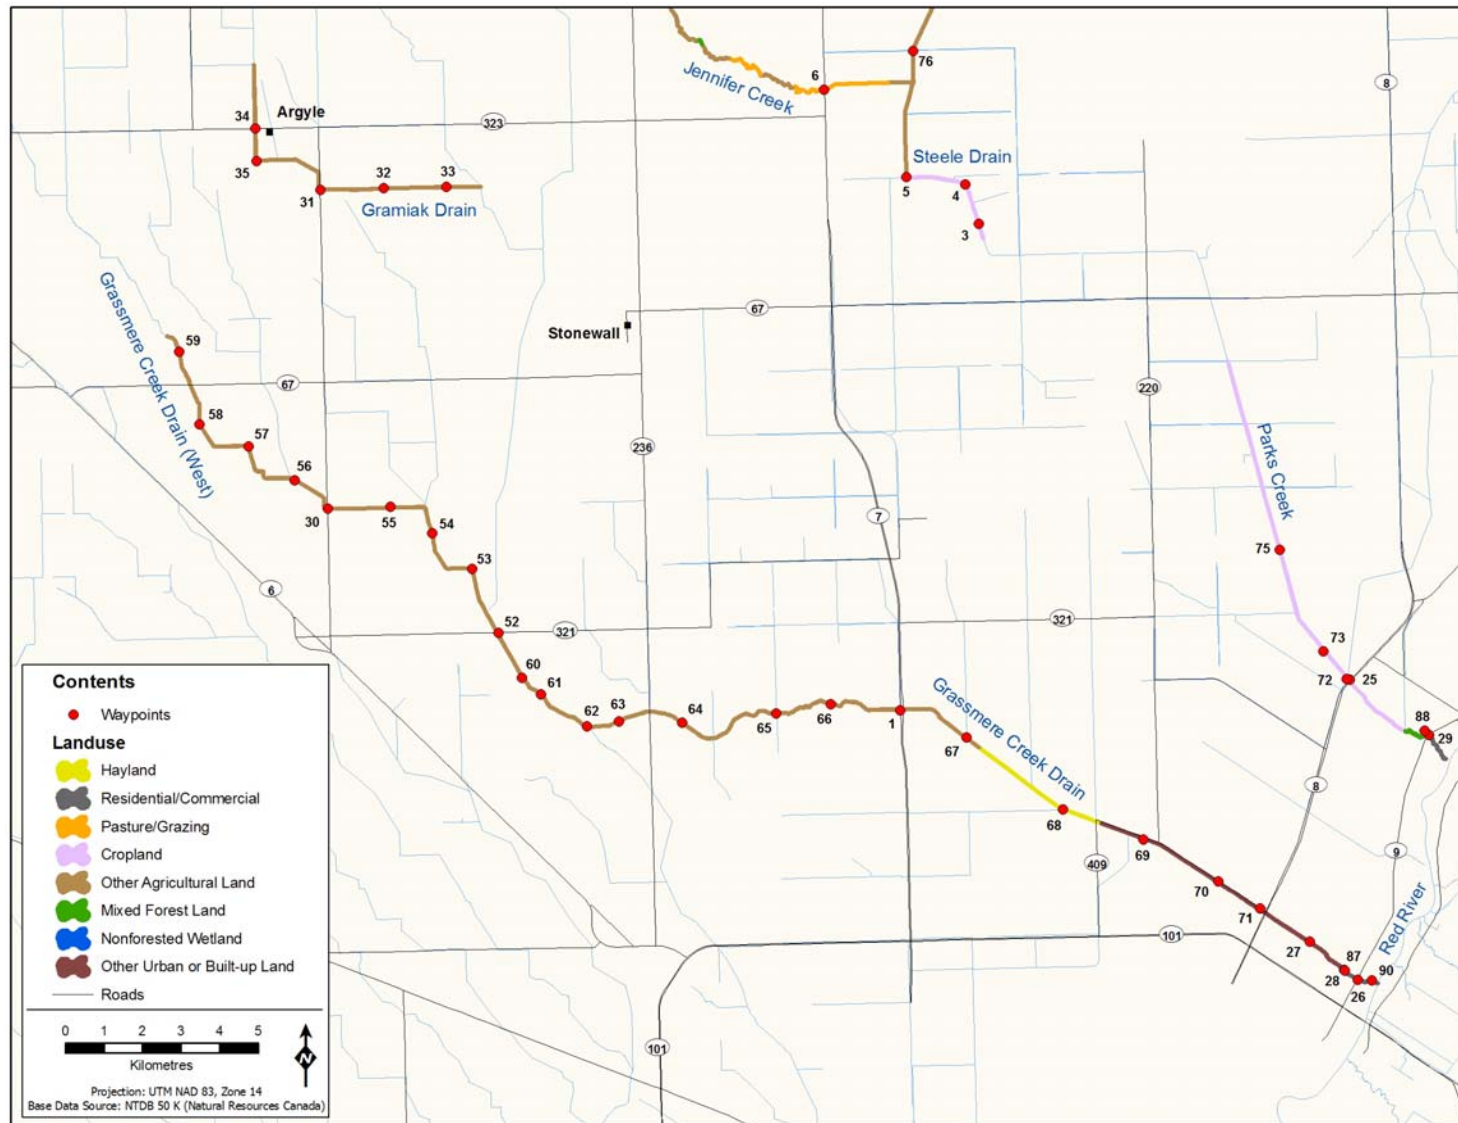
Figure 8. Sites groundtruthed throughout the southern portion of Watershed 05OJ, indicated by waypoint #, and specific land use/cover identified, 2007.
