**EAST INTERLAKE CONSERVATION DISTRICT:
WATERSHED 050J RIPARIAN ASSESSMENT SURVEY – WITH
EMPHASIS ON THIRD ORDER DRAINS and HIGHER – 2007 and 2008**

P. G. Graveline

2008

North/South Consultants Inc.
Aquatic Environment Specialists

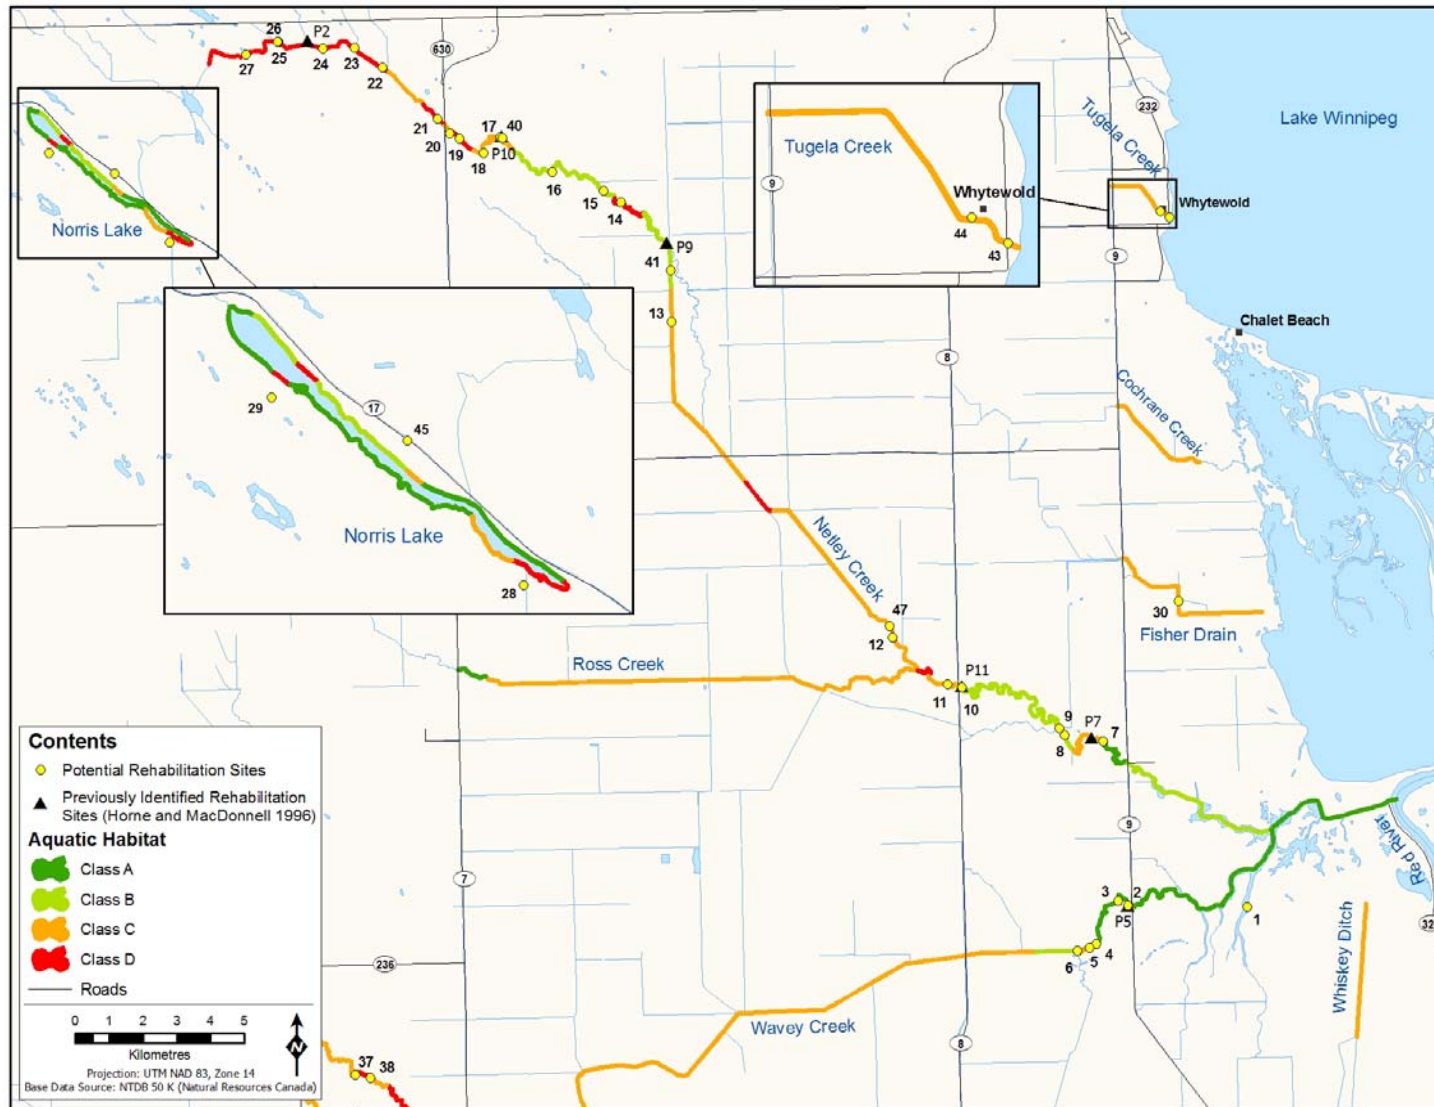
Figure 9. Aquatic habitat quality ratings and potential rehabilitation sites (including previously identified sites) identified throughout the northern portion of Watershed 050J, 2007.

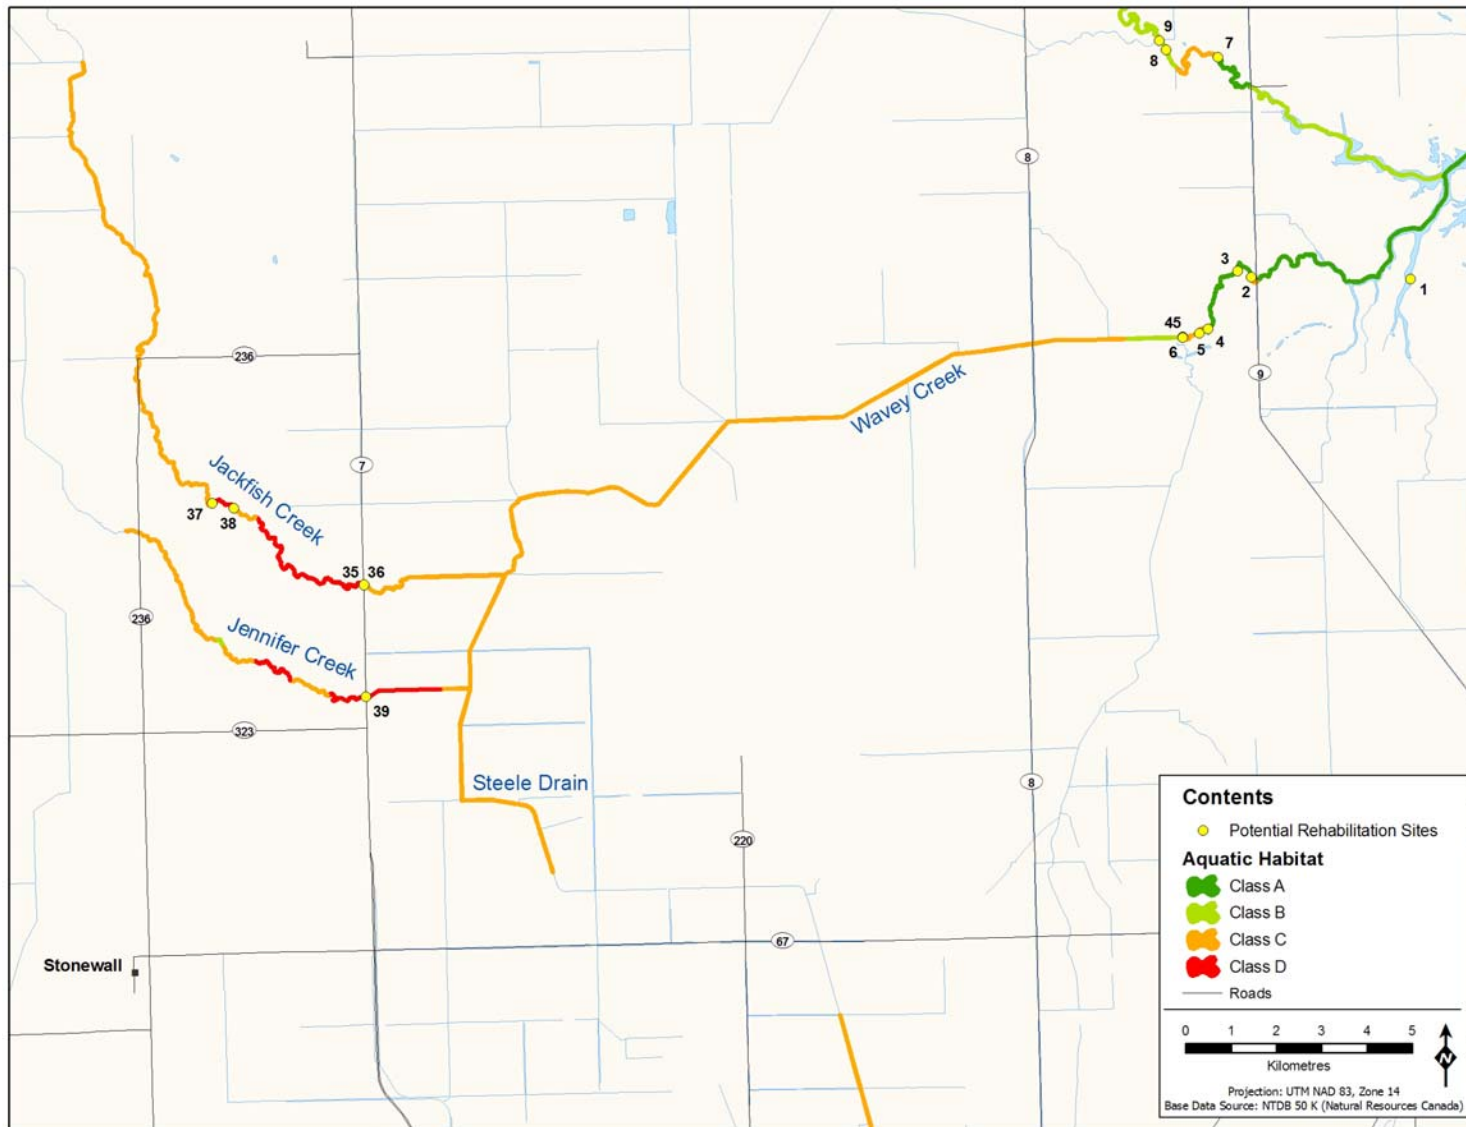
Figure 10. Aquatic habitat quality ratings and potential rehabilitation sites (including previously identified sites) identified throughout the central portion of Watershed 05OJ, 2007.

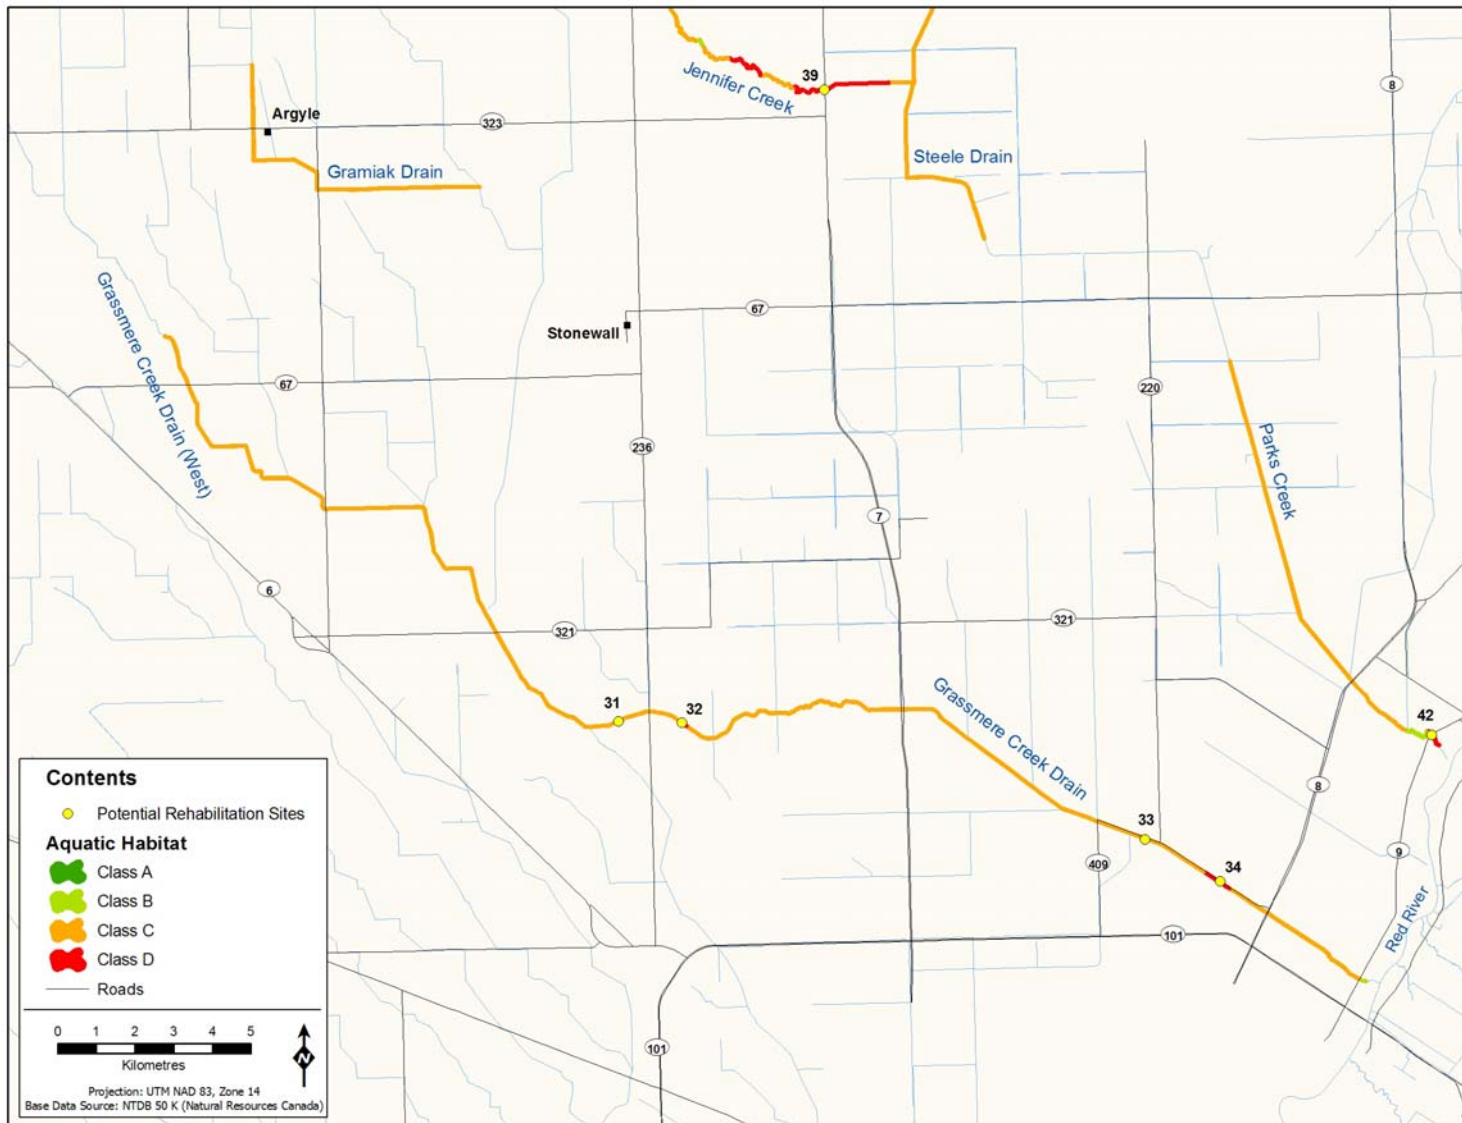
Figure 11. Aquatic habitat quality ratings and potential rehabilitation sites (including previously identified sites) identified throughout the southern portion of Watershed 05OJ, 2007.
