# **An Inventory of Private Water Wells in the Fisher River (05SD) Watershed**

**Prepared by:**

East Interlake Conservation District

**December 2010**

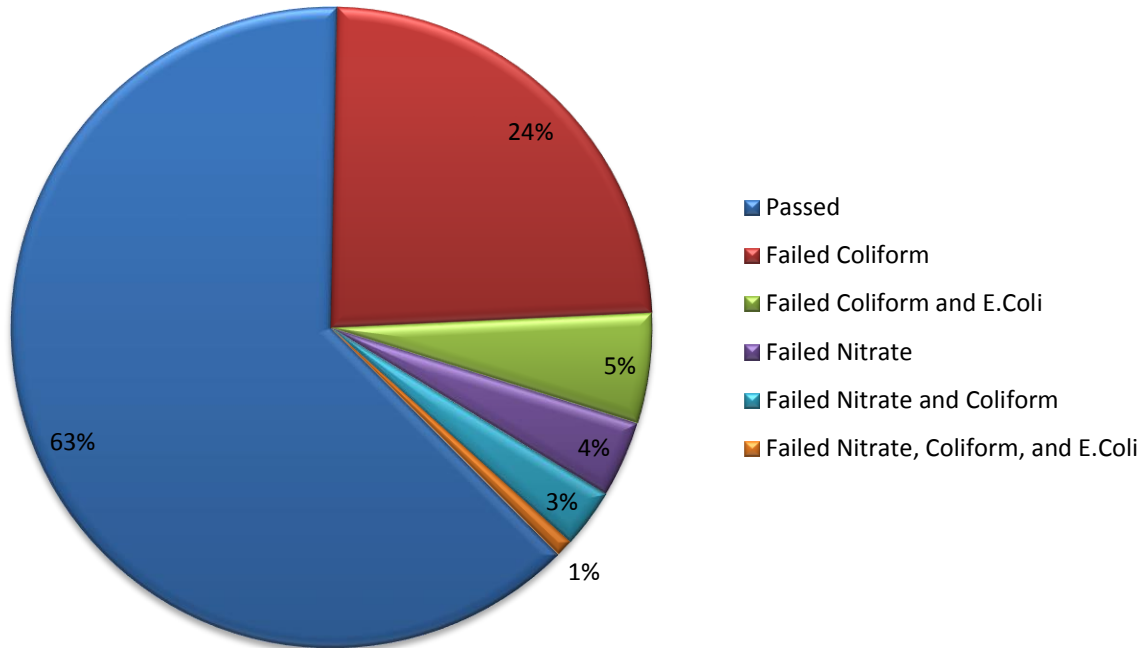
**Figure 3: Summary of Well Water Samples in the 05SD Watershed**

Of the 234 wells that were sampled for bacteria and nitrate levels, 37.2% (87) of the well water samples failed the Canadian Drinking Water Guidelines (CDWG) for bacteria and/or nitrate. A summary of results is shown in Figure 3.

### Summary of Well Water Sample Results in the 05SD Watershed

Prior to implementation of this program, detailed information regarding the health of the aquifer directly under watershed Fisher River was not available. A key finding as a result of this program was that 37.2% of rural water wells failed to meet basic Canadian Drinking Water Quality guidelines in this watershed. High rainfall and excess moisture in the area in 2010 could have contributed to the nearly 1 in 3 failure rate. Hopefully increased programming targeted at rural audiences regarding proper maintenance and well installation can decrease this statistic even further. This program acted as an initial education campaign and hopefully raised the public's awareness of drinking water quality in watershed 05SD.

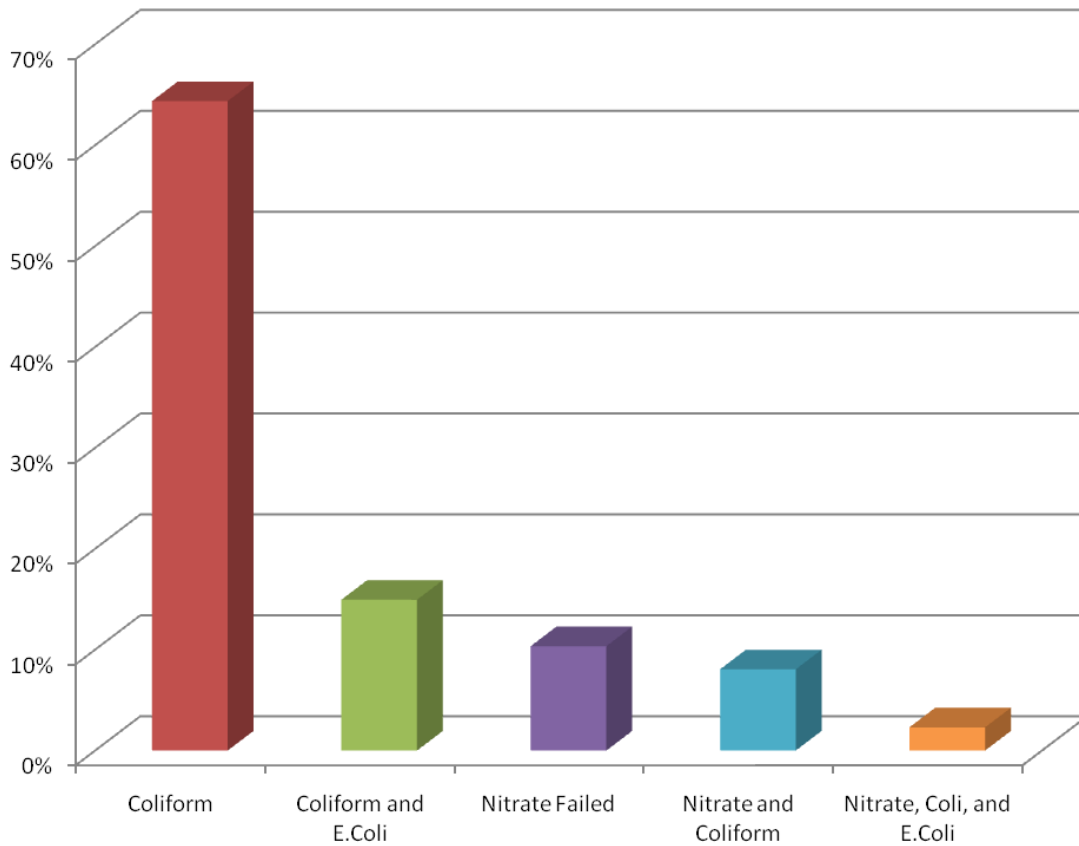
**Figure 4: Reasons for Well Water Test Failures in the 05SD Watershed**

Of the 37.2% (87) of the wells that failed, 64.4% (56) failed due to total coliform counts, 14.9% (13) failed for both *E. coli* and total coliform, 10.3% (9) failed nitrate, 8% (7) failed nitrate coliform, and 2.3% (2) failed all three parameters (coliform, *E.coli*, and nitrate). The reasons for well test failures are shown in Figure 4.

The data gathered through the partnership between the EICD and Water Stewardship will be crucial to the successful development of a watershed management plan for the region. It is recommended that a continued partnership exist to retest in the future to see drinking water quality improvements have been made.
