**EAST INTERLAKE CONSERVATION DISTRICT:
ICELANDIC RIVER WATERSHED RIPARIAN ASSESSMENT
SURVEY – WITH EMPHASIS ON THE ICELANDIC RIVER AND
ASSOCIATED DRAINS – 2006 and 2007**

P. G. Graveline and J. Larter

2007

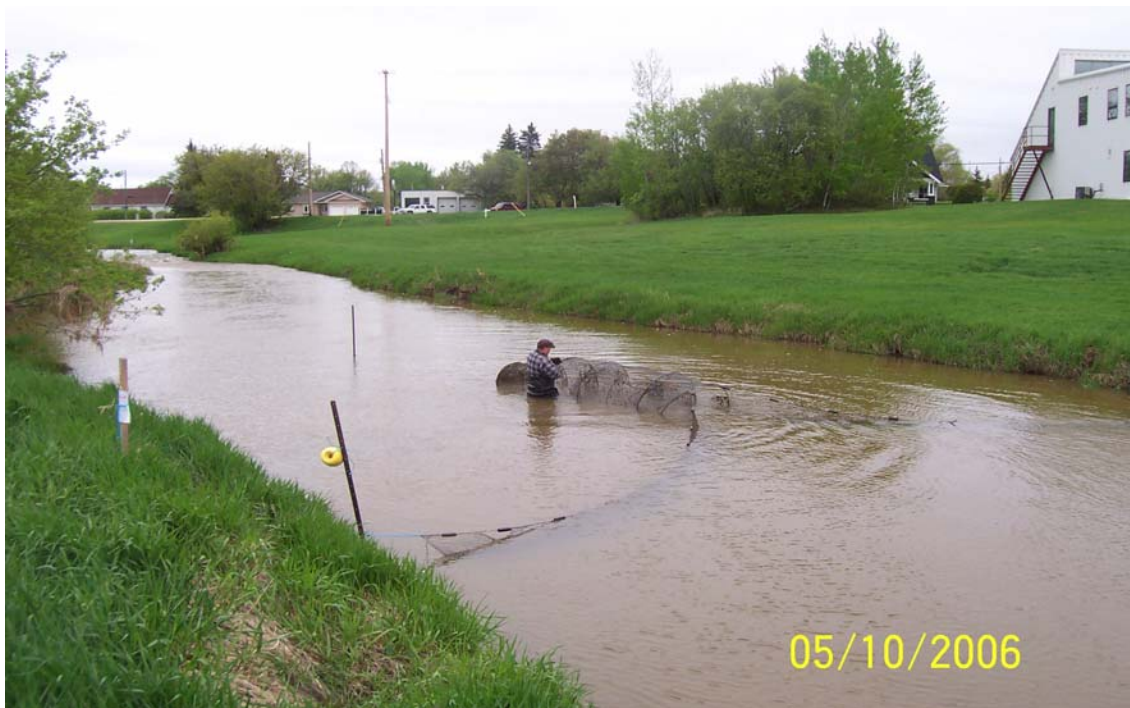
Photo 1. Example of hoop nets used to capture migrating fish. This hoop net was located approximately 100 meters downstream of the Arborg Dam.

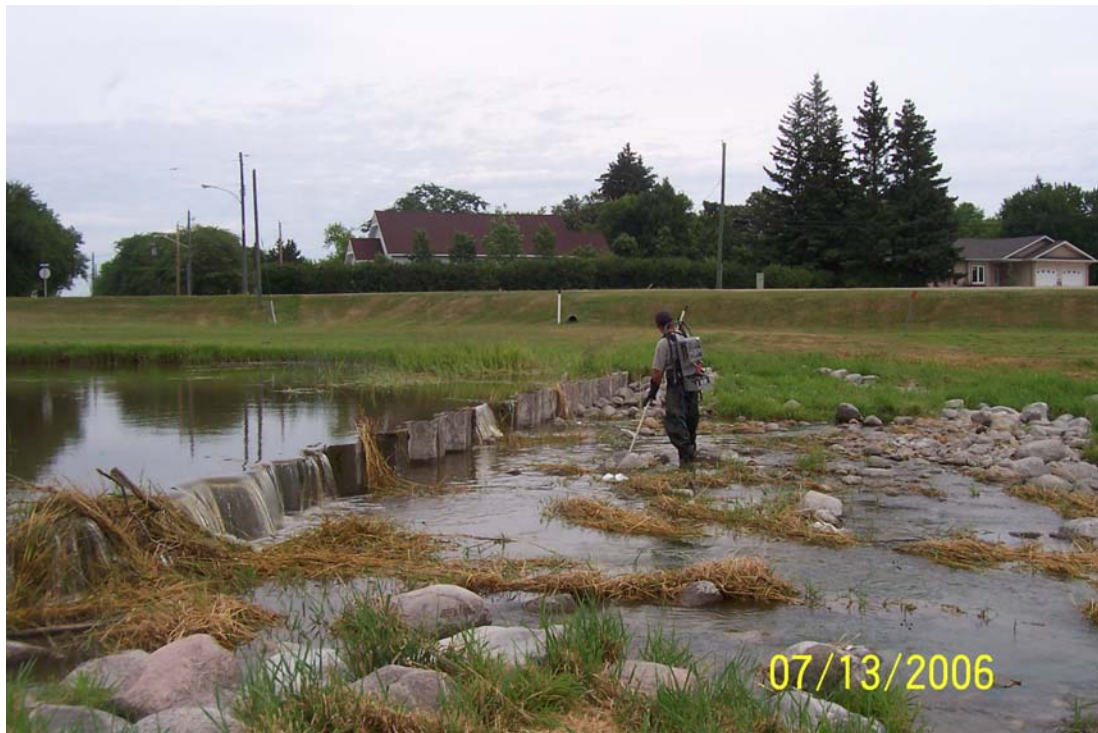
Photo 2. Back-pack electrofishing just downstream of the Arborg Dam.

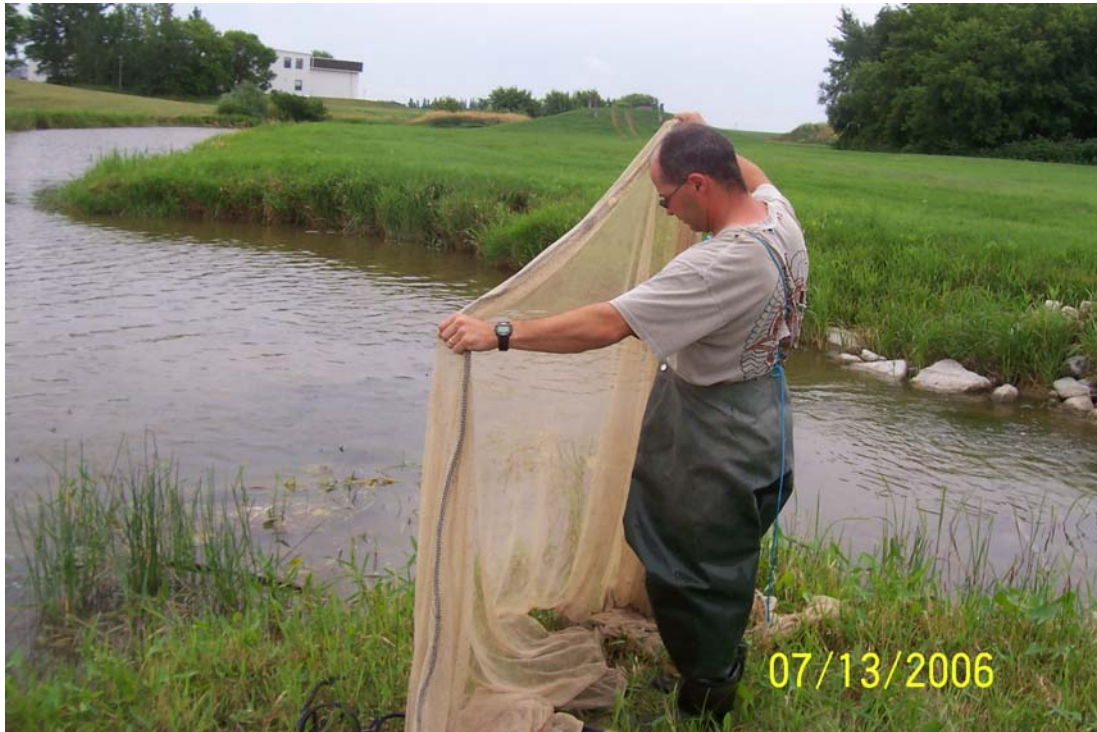
Photo 3. Beach seine used to capture small bodied fish on the Icelandic River. This location is just downstream on the Arborg Dam.

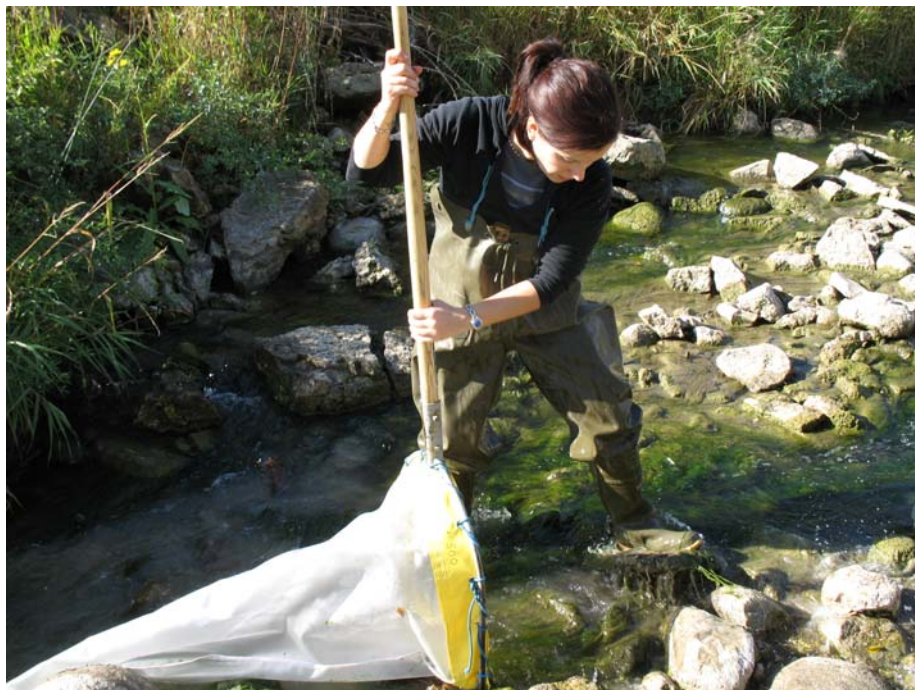
The kick net used was constructed of 500 μm nitex mesh, having an aperture of approximately 0.25 m^2 (Photo 4). The field technician stood in the selected site with their back facing upstream, kicking up the substrate and then sweeping above the disturbed area to capture dislodged or escaping invertebrates into the kick net. The technician passed over an approximate 1 m^2 area twice in a standard time interval (e.g., 5 minutes), frequently emptying the net contents into a bucket to reduce sample loss and net clogging.

Photo 4. Example of kick net used and collection of invertebrates by technician.

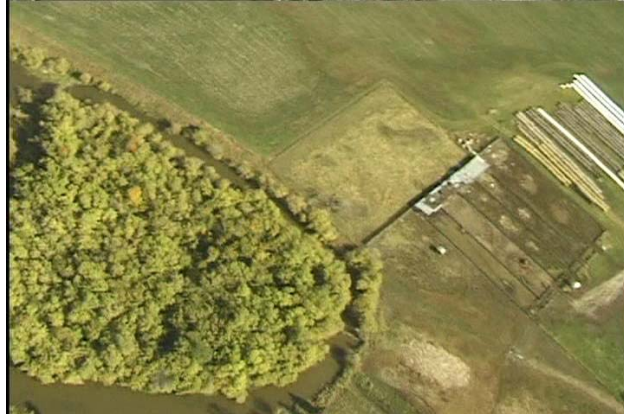
Other Agricultural Land: This category is applied when separate land uses cannot be mapped individually and may include residential, commercial, or industrial practices (Anderson et al. 1976). In addition to the Anderson et al. (1976) definition, this classification is also inclusive of farmsteads, holding areas for livestock (i.e., corrals), and structures associated with agricultural practices (e.g., barns, storage silos, etc.). Typically, practices under this category are on a smaller scale than confined feeding operations or mixed urban/built-up land uses (for example).

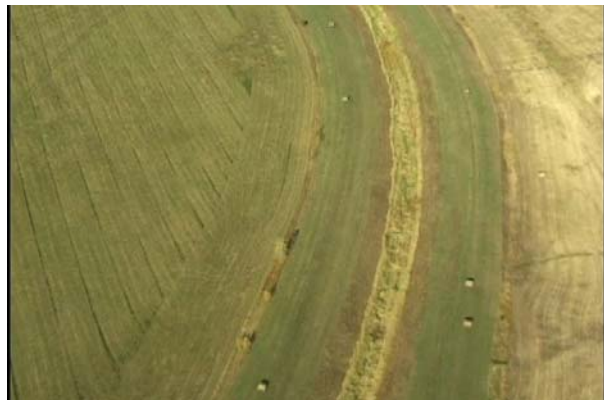
Hayland: This category is defined as land used for the production of forage crops for livestock (e.g., alfalfa, timothy, etc.). Hayland crops are often characterized by hay bales spotting the landscape adjacent to watercourses. In the Icelandic and Washow Bay watersheds, hayland is often associated with cropland, where hayland consists of narrow strips along the riparian zone and cropland extends out beyond the hayland.

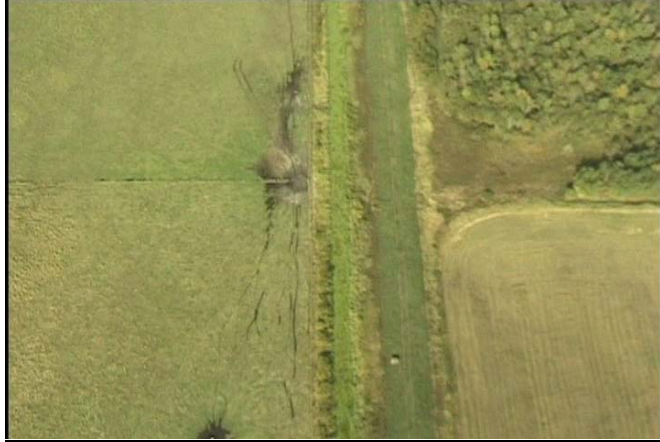
Pasture/Grazing: Areas of land used for livestock operations are classified as pasture/grazing. This land use was generally characterized by a smooth texture resulting from grazed herbaceous cover. Pasture/grazing are often associated with heavily defined linear tracks and, where applicable, fence lines. Pastures in forested areas are identified by a decreased density of trees within the forest stand.

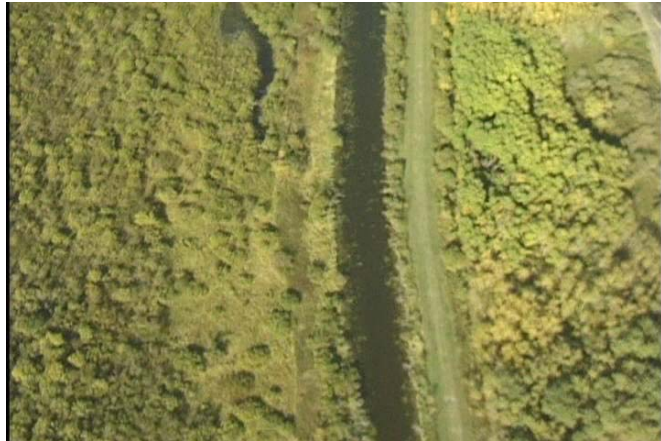
Deciduous Forest Land: Areas dominated by forest land (e.g., mixed deciduous) tend to be more ‘natural’ and have few linear or man-made patterns. Forest land is characterized by a smooth texture and a randomly undulating ‘cellular’ pattern, resulting from the tree crowns.

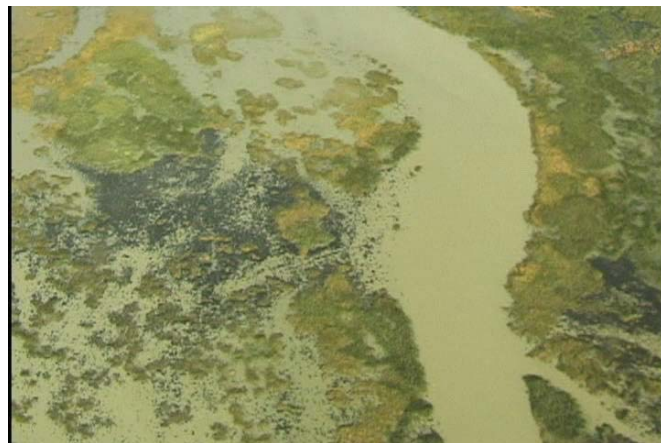
Non-Forested Wetland: This category is defined as an area dominated by natural herbaceous vegetation. These areas tend to be more ‘natural’, have few linear patterns, and are characterized by smooth, undulating textures and random patterns.

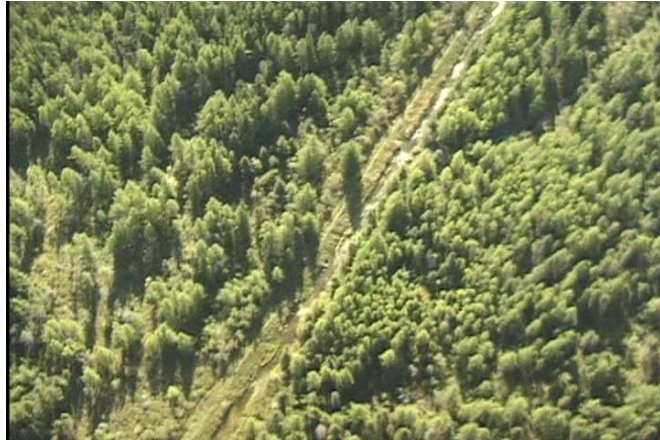
Mixed Forest Land: This classification includes forested areas where evergreens and deciduous trees are growing, yet neither predominates (Anderson et al. 1976). The Icelandic and Washow Bay watersheds contain parcels of mixed forest lands throughout. The contrast between coniferous and deciduous tree species is much more prominent in the fall.

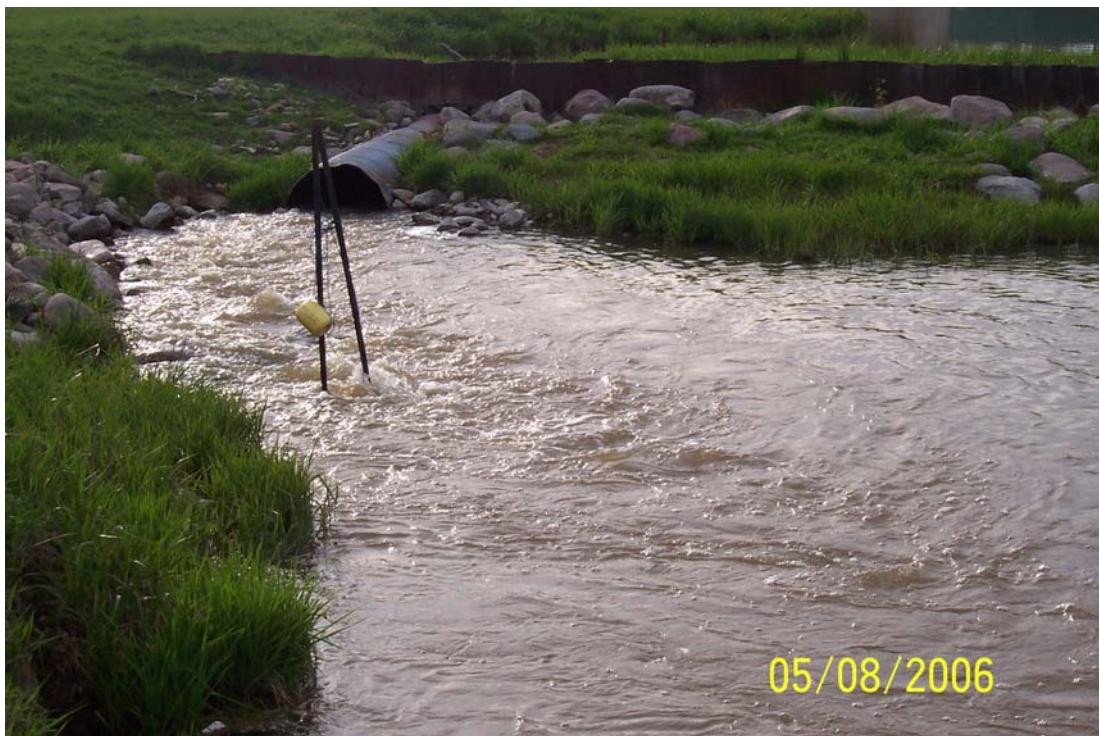
Photo 5. Arborg Dam culvert outlet and drift trap placement on May 8, 2006.

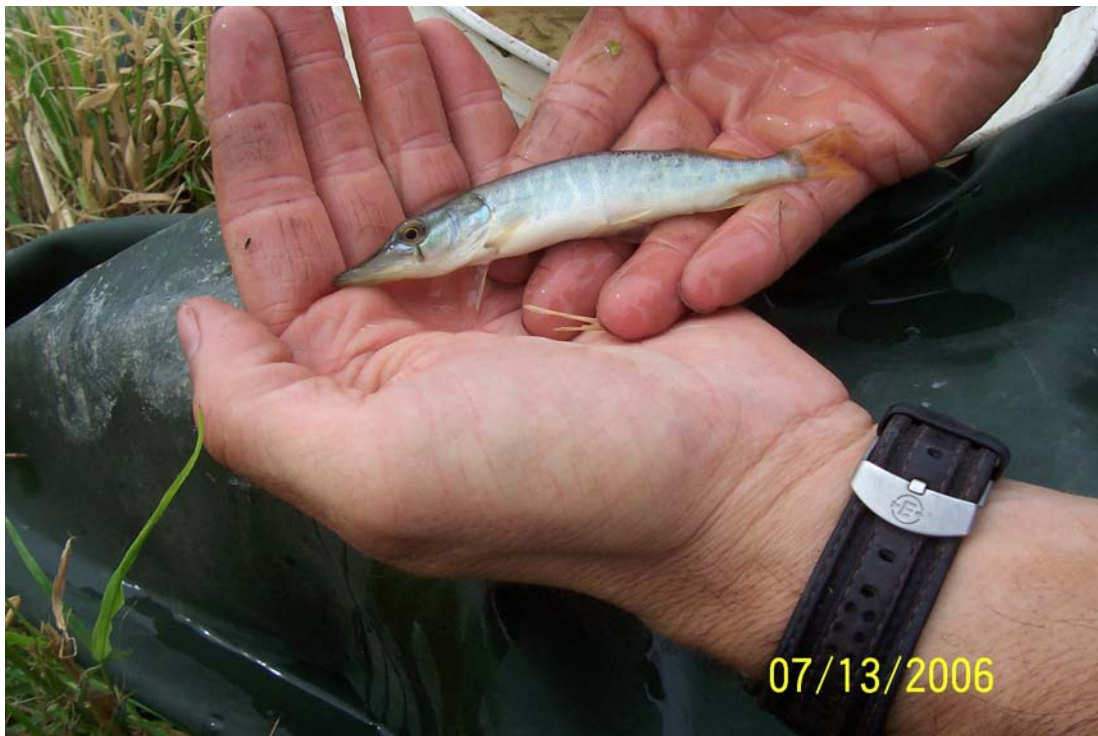
Photo 6. Northern pike captured by back-pack electrofishing just downstream of the Arborg Dam.

A total of three northern pike were captured, two of which were likely young-of-the-year, with fork lengths of 110 mm (Study Point 17) and 115 mm (Study Point 22) (Photo 6). Two young-of-the-year white suckers (mean length of 33 mm) were captured upstream of the fish ladder (Study Point 19).

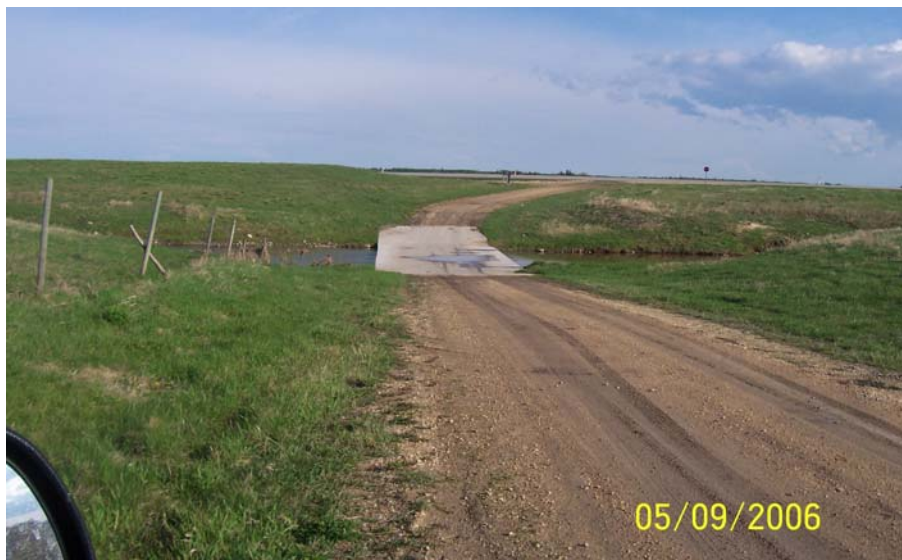
The first of these barriers is a cement ford located approximately five km downstream of the town of Arborg (Appendix 5.2, Figure 10) (Photo 7). The ford has five culverts and is

Photo 7. Cement ford located approximately 5 km downstream of the town of Arborg on the Icelandic River.

approximately 20 m in length. In 1990, Manitoba Fisheries Branch conducted a longitudinal profile in the vicinity of this ford (MWSFB, Icelandic River file, circa 1990) and found that it should not be a barrier to fish passage with respect to: a) adequate flows in the spring; and b) the presence of culverts to provide additional upstream access. However, under certain water levels fords of this nature can act as barriers to both upstream and downstream migrations of fish (e.g. velocity barrier, inadequate flows, etc.). Without proper maintenance, the culverts can also become fouled with debris. Therefore, all fords of this nature are classified as potential barriers to fish passage (as discussed in Section 2.3.4). A similar barrier was identified approximately two km downstream of the gradient control structure/fish ladder (Figure 10). This ford has previously washed out, but has since been repaired.

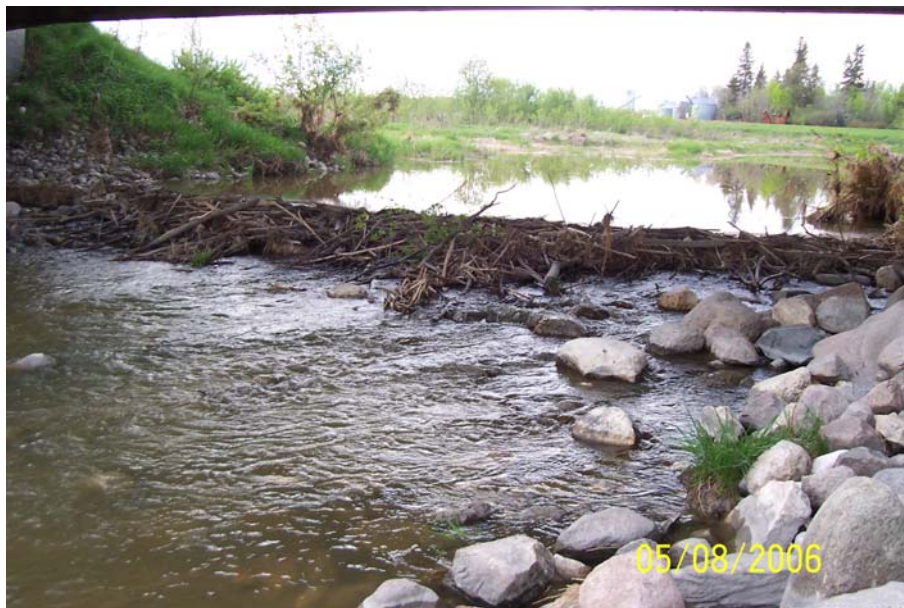
Still downstream of the fish ladder, one beaver dam located under the Framnes Bridge may temporarily block movements of fish (Photo 9). Another section of the Icelandic River, report ID #55, had an altered flow regime and what appeared (by video) to be an instream obstruction. This site is likely a barrier to fish migration and warrants additional investigation.

Photo 9. Beaver dam located under the Framnes Bridge, May 8 2006.

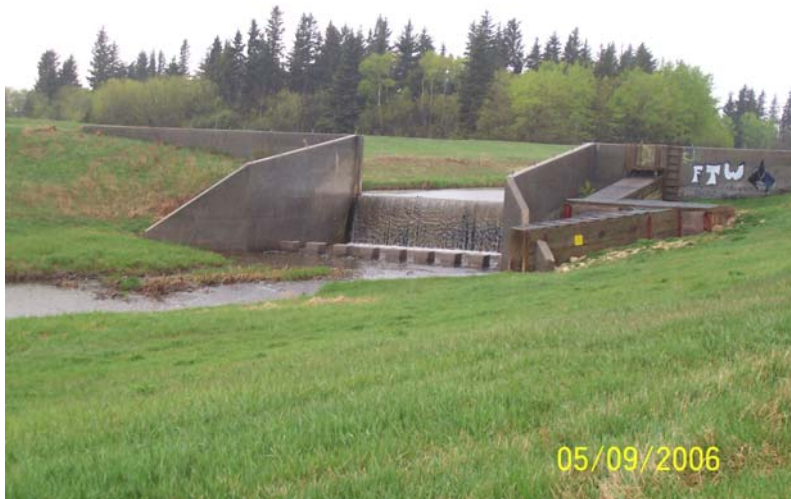
In 1969, the Water Resources Branch constructed a concrete drop structure on the Icelandic River to decrease the channel gradient of the river and to minimize channel degradation post-channel and dyke reconstruction (MWSFB, Icelandic River file, circa 1996) (Photo 10). As this structure effectively blocked spawning migrations of fish (i.e., walleye to upstream

Photo 10. Gradient control structure and modified Denil fish ladder (on right).

natural reaches) plans were devised to include fish passage at this site. By 1996, a modified Denil fish ladder was implemented at the gradient control structure and initial reports indicated that the ladder was successful at allowing fish passage (i.e., walleye, northern pike, and suckers) (MWSFB, Icelandic River file, circa 1998).

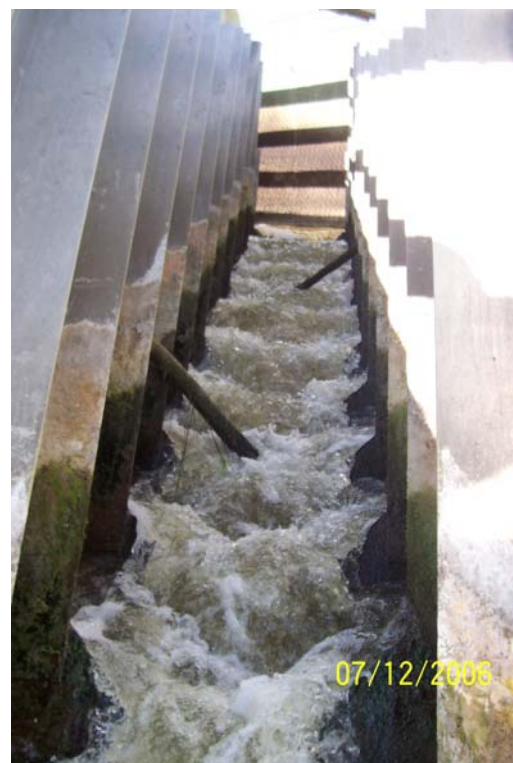
Currently, the effectiveness of the fish ladder is questionable. Investigations in the spring and late summer of 2006 indicated that velocities (observed) at the ladder may be too great to adequately allow passage of spring spawning species (Photo 11). In addition, the outlet located on the upstream side of the dam was blocked with debris (Photo 12). This blockage may prevent fish passage both upstream and downstream of the ladder. In late summer, one deceased northern pike was observed on the upstream side of the outlet, washed against the debris. The effectiveness of the ladder at passing fish in the spring should be reviewed. However, the efficiency of the ladder is also decreased by any downstream barriers (man-made or natural) that may also impede the passage of fish.

Photo 11. Flow conditions observed at the downstream side of the gradient control structure fish ladder, July 12, 2006.

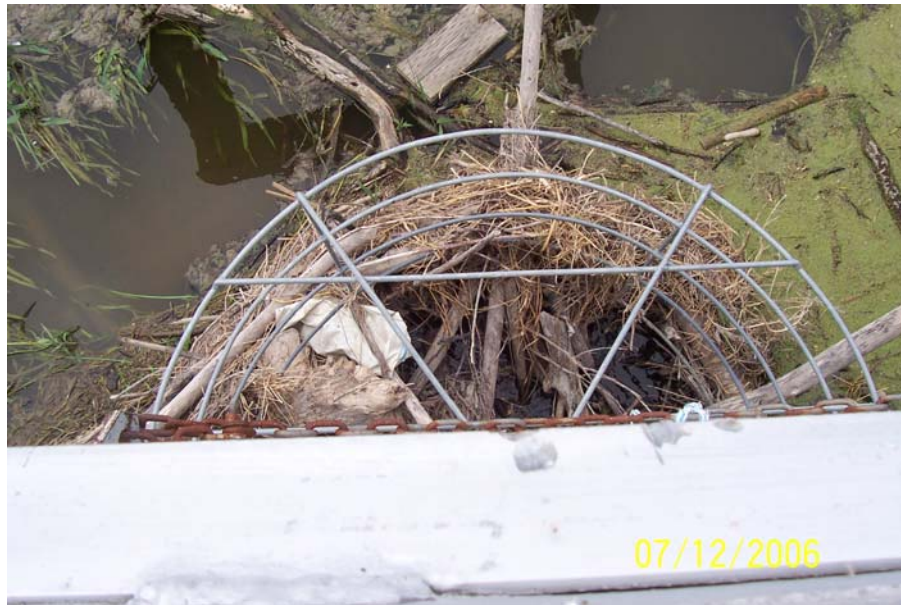
Photo 12. Debris clogging upstream end of fish ladder.

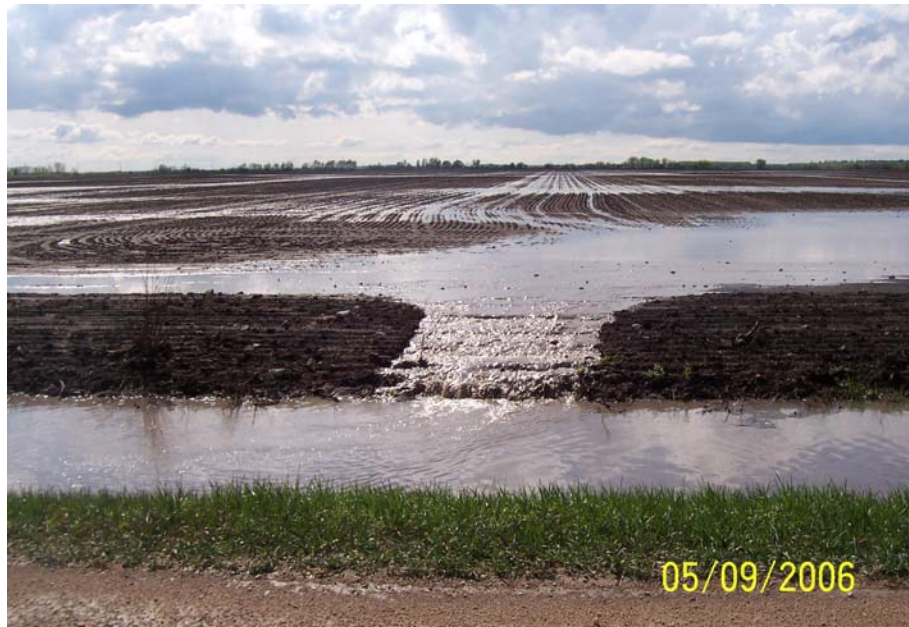
For example, heavy spring rains in 2006 resulted in the ‘ponding’ of water on an un-vegetated field (Photo 13). The ponded water then transported sediments into a roadside ditch, which would eventually make its way to the Icelandic River.

Photo 13. Ponded water on an un-vegetated field and subsequent run off into a road side ditch.

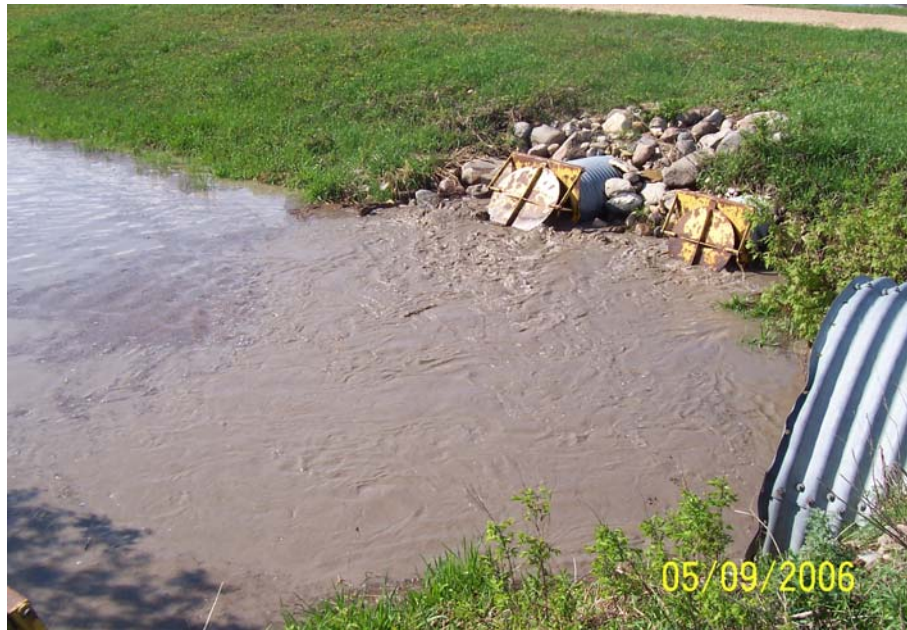
On May 9, a turbidity reading taken in the Shurkas Drain measured >1000 NTU (Table 7). This reading was taken during a heavy rain fall event downstream of a non-vegetated field. Sediments were observed being flushed into the Shurkas Drain from a roadside ditch.

Turbidity readings taken at the Shurkas Drain, downstream of the runoff were greater than 1000 NTU (Photo 14). Although not measured during this study, this direct runoff could contain elevated levels of phosphorus and nitrogen. The implementation of newly proposed buffer setback distances and modified land use practices could assist in the reduction of erosion and improve water quality (Manitoba Water Stewardship 2005).

Photo 14. Shurkas Drain and roadside ditch where a turbidity reading was greater than 1000 NTU.

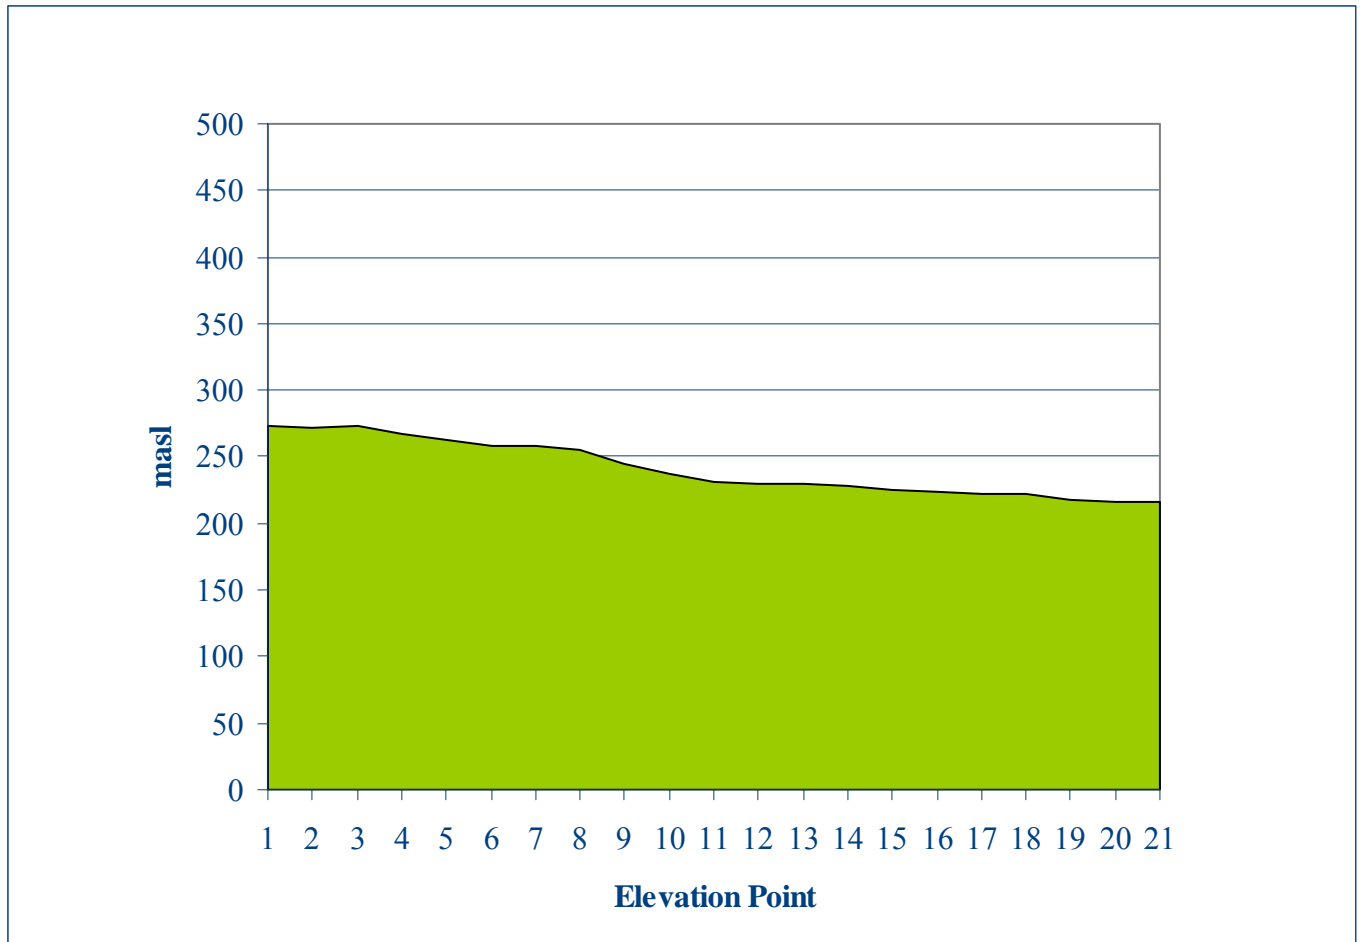
Figure 2. Elevation profile of the Icelandic River (elevation in masl).

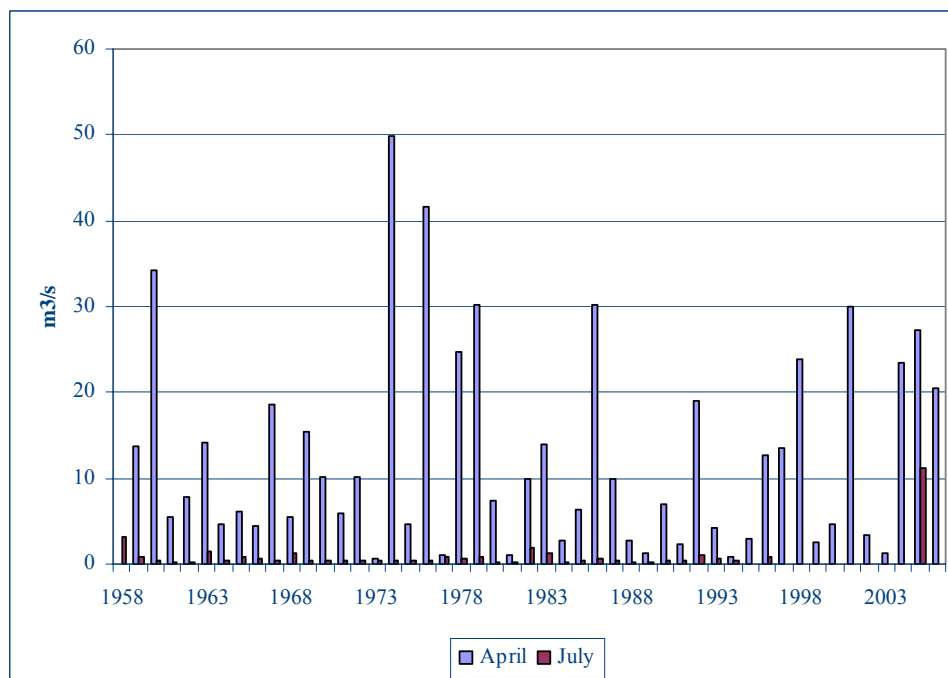
Figure 3. Mean monthly discharges in the Icelandic River (Station #05SC002 near Riverton) from 1958 to 2006 (Source: Environment Canada, Water survey of Canada, 2006).

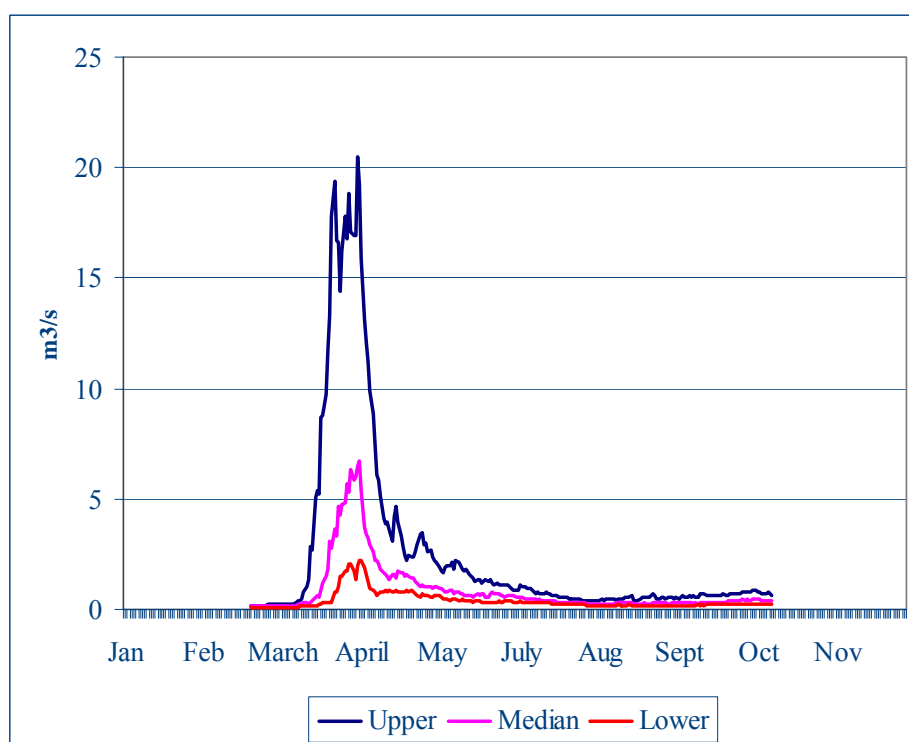
Figure 4. Median, upper and lower quartile flows for the Icelandic River (Station #05SC002 near Riverton) from 1958 to 2006 (Source: Environment Canada, Water Survey of Canada, 2006).

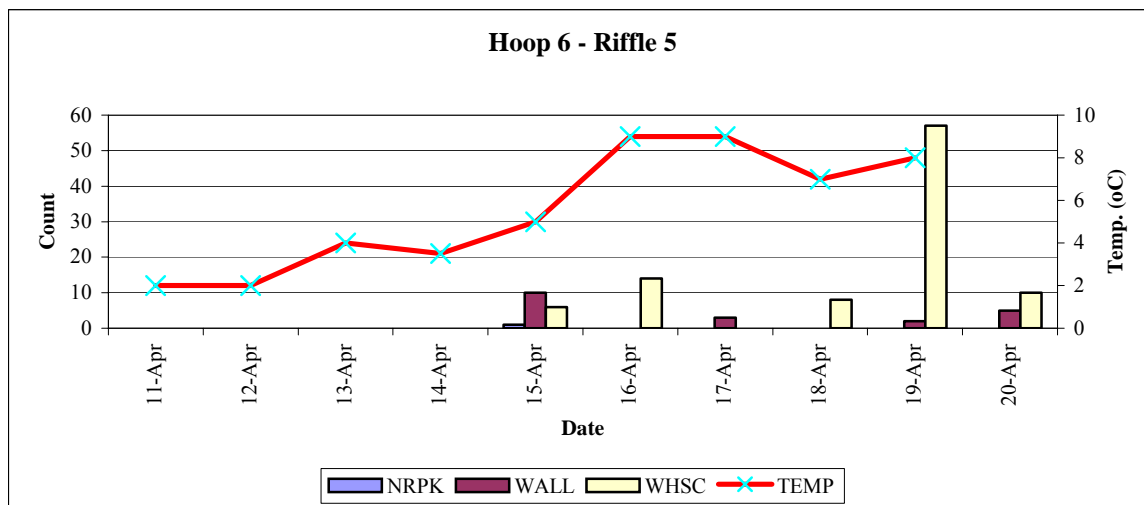
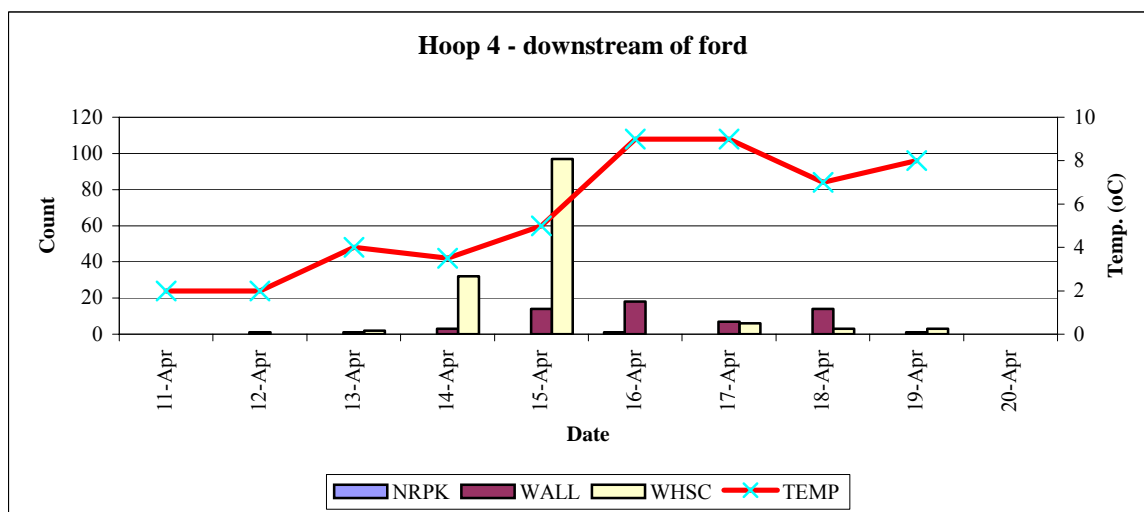
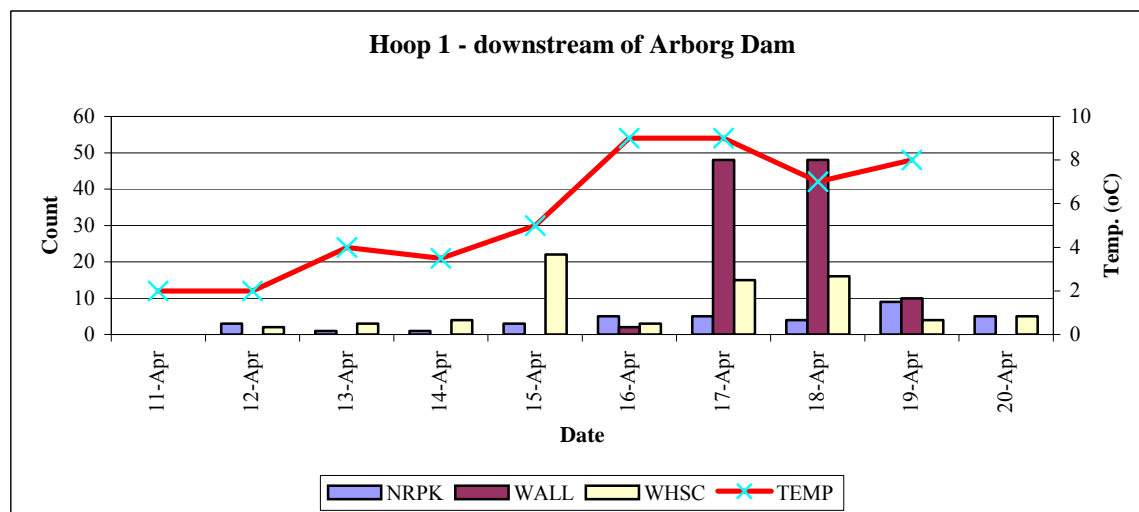
Figure 7. Fish catch, by date and water temperature, at Hoops 1, 4, and 6, spring 2007.
